2020 Corvette: GM TechLink: Corvette Competition Seat Bolster Pad Support

GM TechLink

April 30, 2020

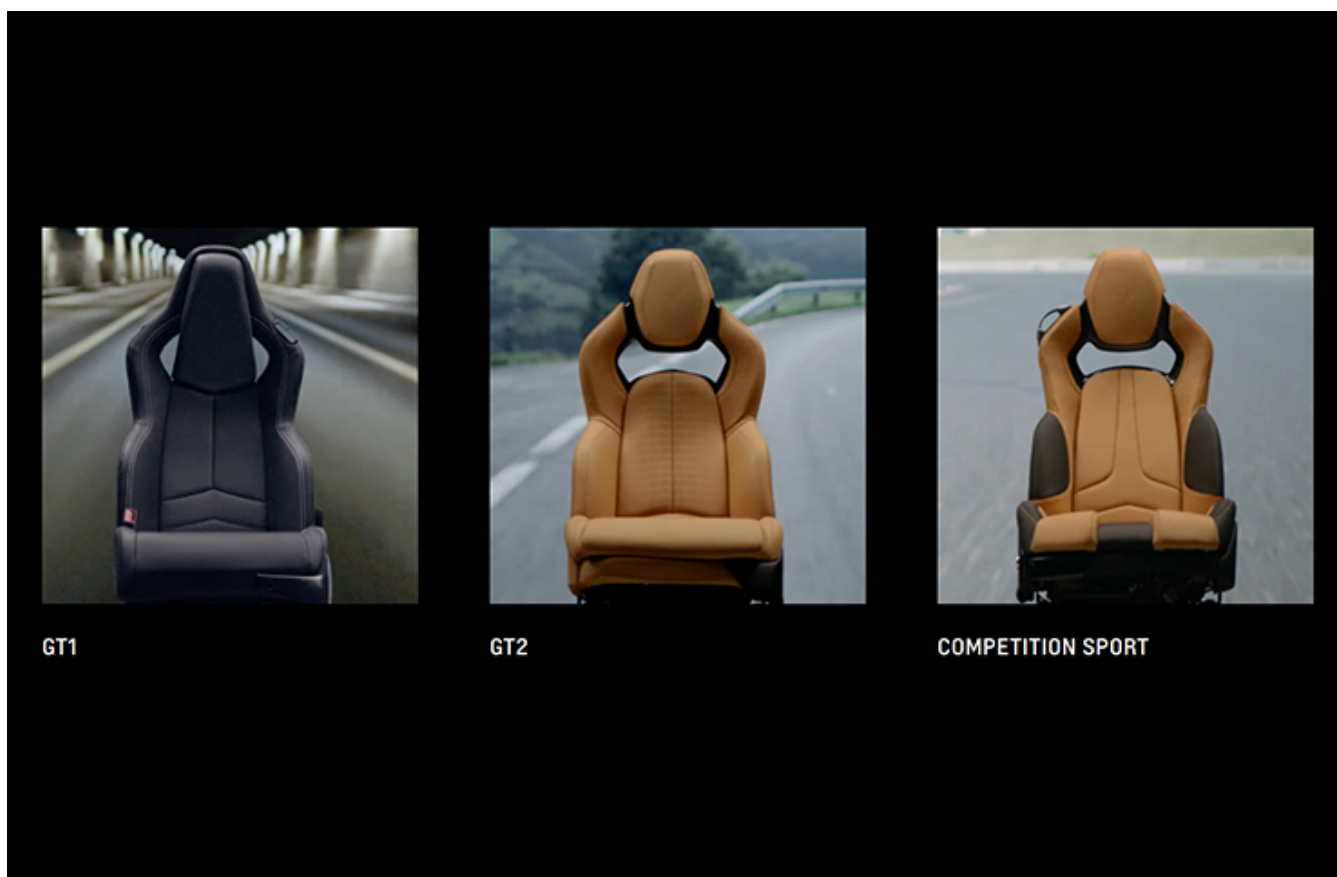
Fig. 1

The all-new 2020 Corvette Stingray features three available seats: GT1, GT2, and Competition Sport. (Fig. 1) On some models with the Competition Sport seats, the sides of the aggressive seat cushion bolsters may have a fit and appearance condition where the seat cushion pad folds under the cushion cover.
