2014 - 2017 Corvette: GM TechLink: Harsh Shift and Rough Idle Conditions

GM TechLink

October 9, 2016

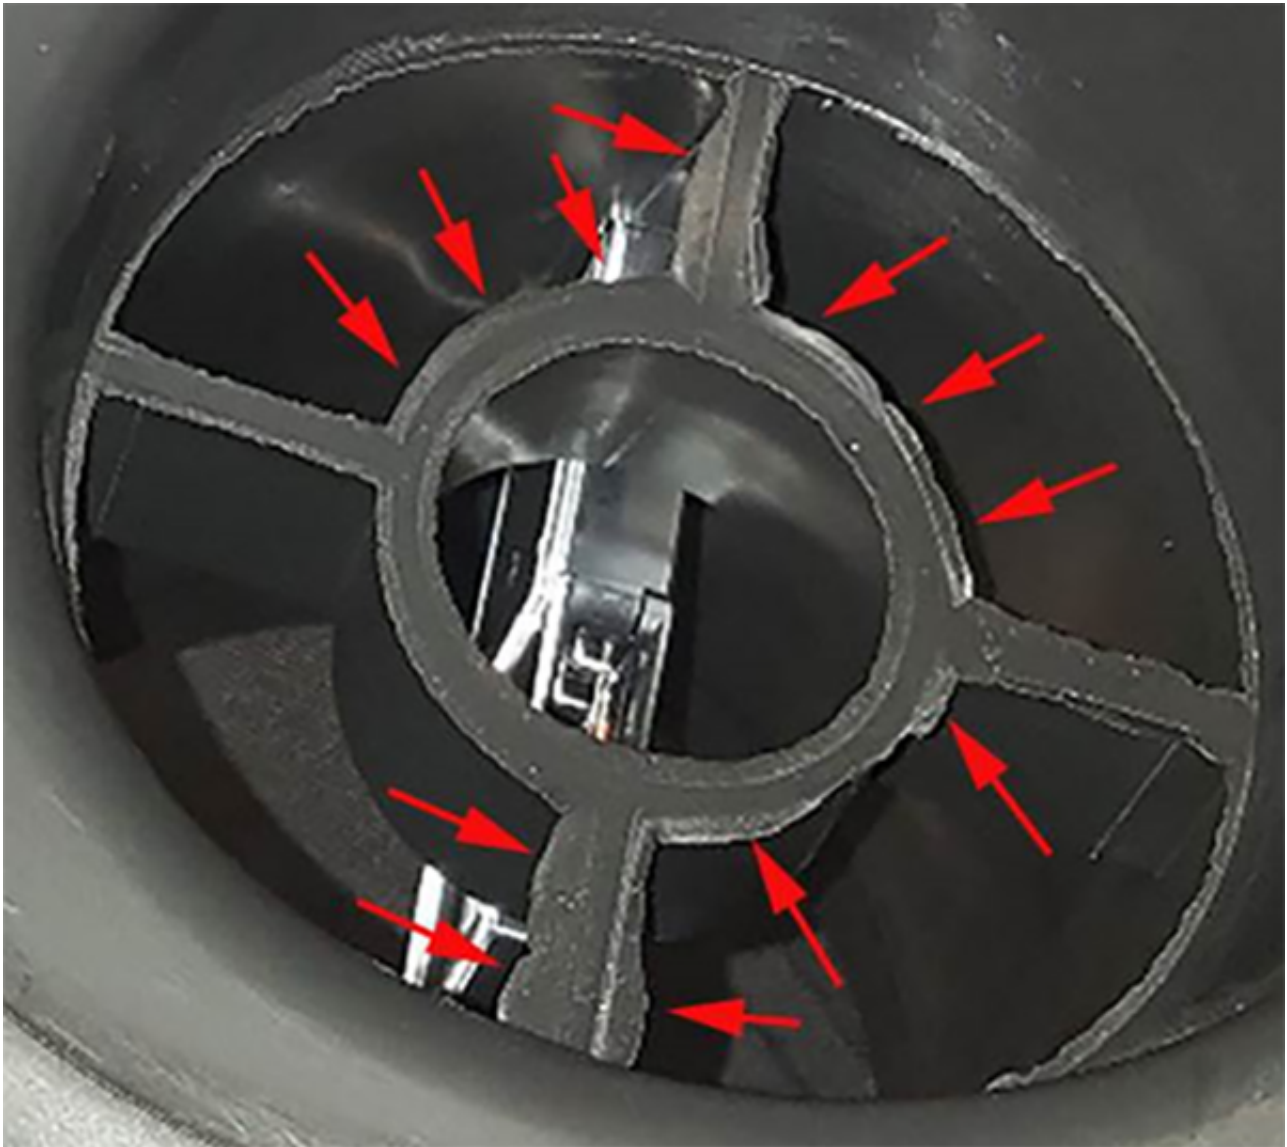
Fig. 11

The harsh shift may be felt on the 1/2 and 2/3 shift along with a sputter when applying the throttle between 0% and 30% and a rough idle. DTCs P0101 (MAF Sensor Performance), P0171 (Fuel Trim System Lean Bank 1), P0172 (Fuel Trim System Rich Bank 1), P0174 (Fuel Trim System Lean Bank 2) and P0175 (Fuel Trim System Rich Bank 2) may be set.

Inspect for cast flashing in the air filter housing near the Mass Air Flow (MAF) sensor for excessive flashing. (Fig. 11) If excessive flashing is found, replace the air filter housing lid. Be sure to check the flashing in the new lid as well.
