2020 Corvette: GM TechLink: Front Fender and Fascia Realignment

2020 Corvette: Front Fender and Fascia Realignment

June 16, 2020
GM TechLink

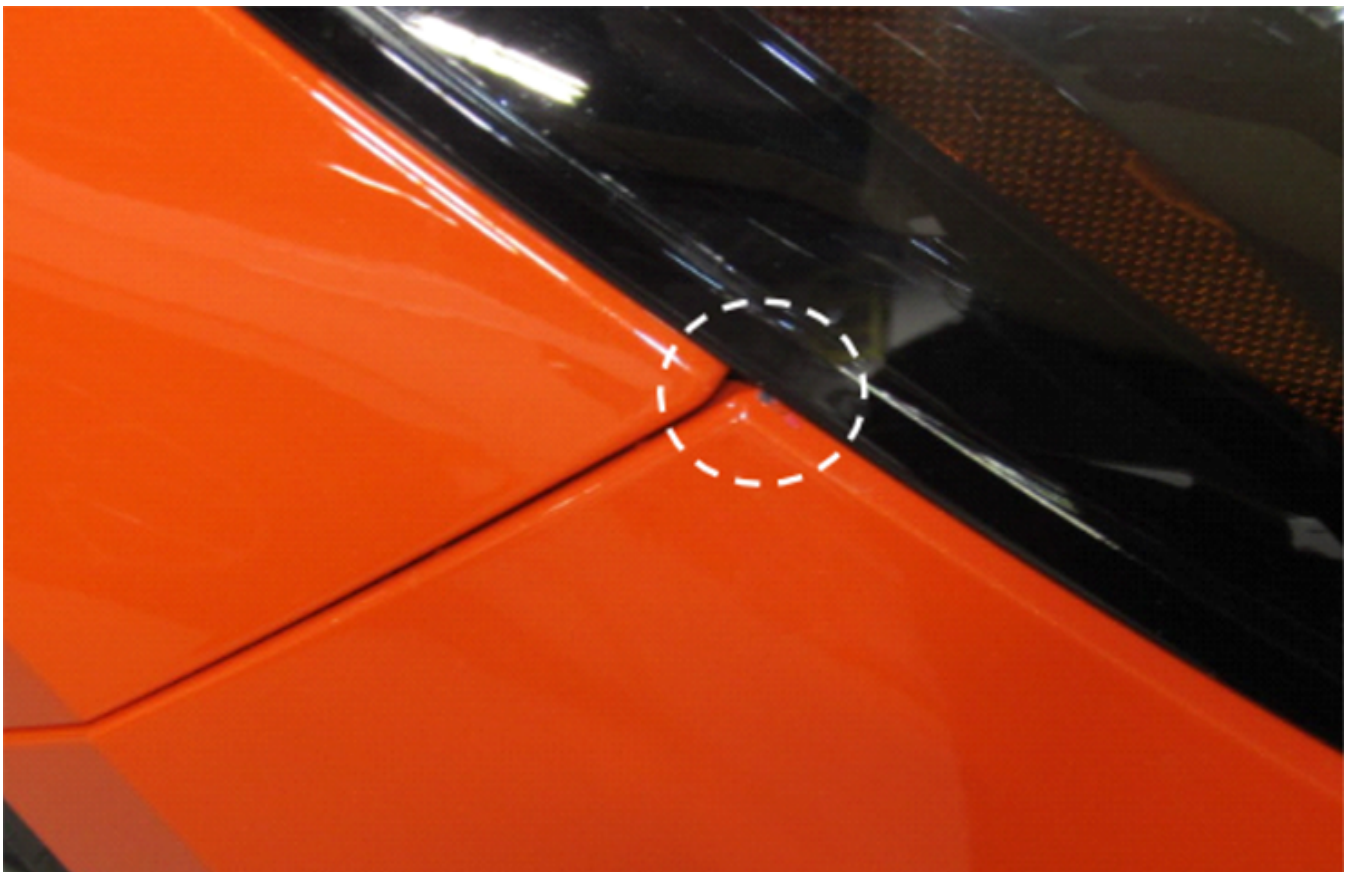
Fig. 10

Some 2020 Corvettes may have a small paint chip in the front fascia below the headlamp on one or both sides of the vehicle. (Fig. 10) The paint chip may be caused by a mis-positioned fender-to-fascia gap joint.

The fender and fascia joint fit should be realigned. (Fig. 11, #1) The realignment will reposition the fender and fascia downward and inboard so that the fascia is flush with the fender. After

Follow the realignment procedure in Bulletin #20-NA-124. The front tire and wheel assembly, front wheelhouse liner and front wheel opening molding must be removed on the affected side of the vehicle.

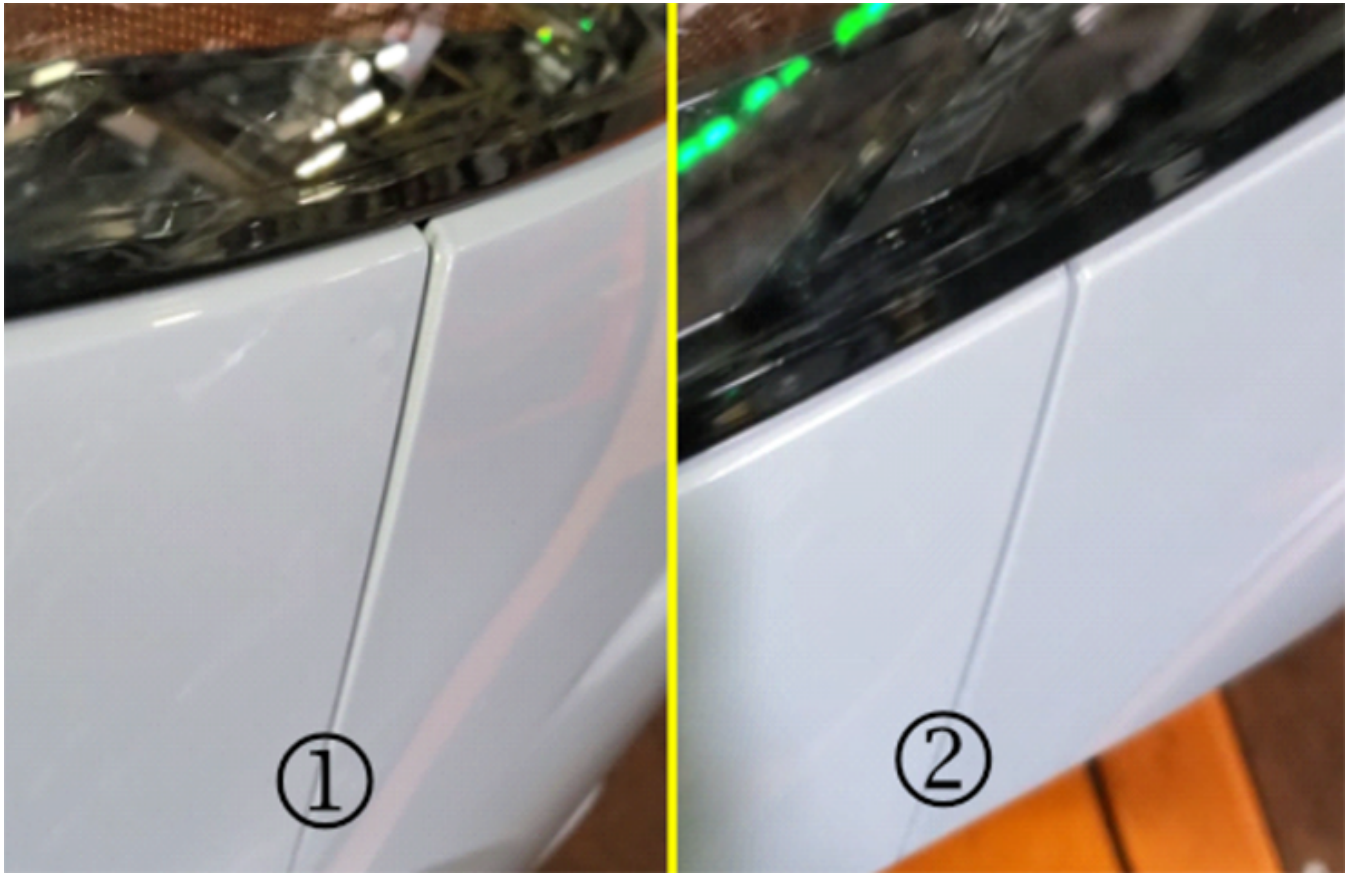
Fig. 11

realignment, the paint chip will no longer be visible. (Fig. 11, #2)

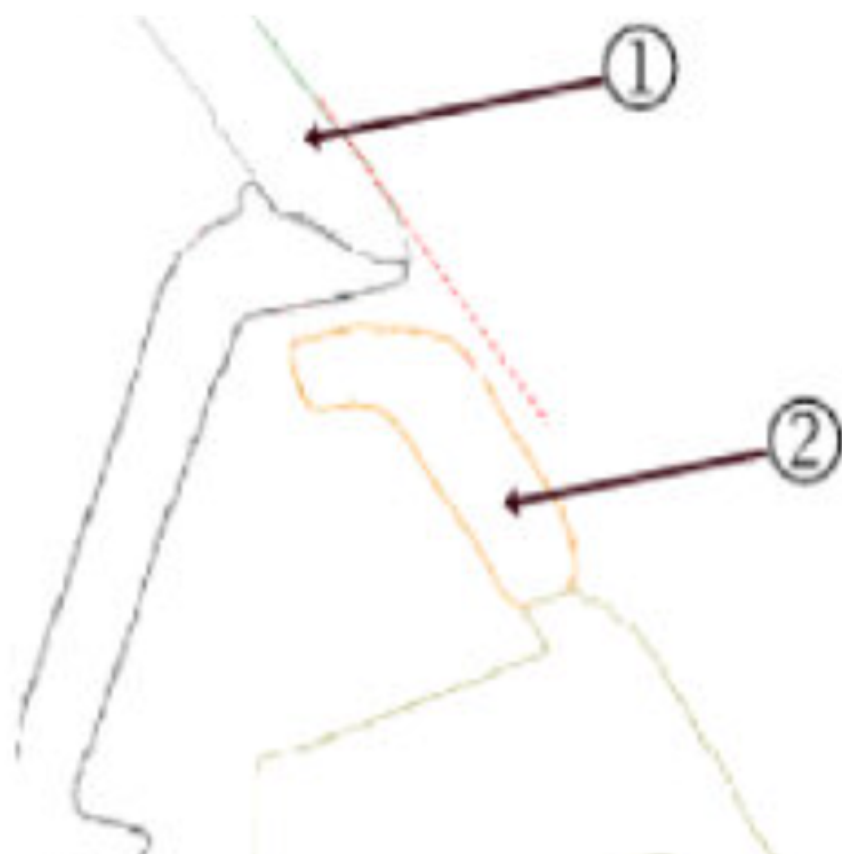
Fig. 12

After adjusting the fender inboard, the headlamp lens (Fig. 12, #1) will be proud of the fender (Fig. 12, #2) and the fascia tip will install below the headlamp lens. (Fig. 13)
