# 2005 - 2020 Corvette: Service Bulletin: #PIC6378A: Diagnosing Various Concerns On A Power Folding Top - (Oct 29, 2020)

**Subject:** Diagnosing Various Concerns On A Power Folding Top

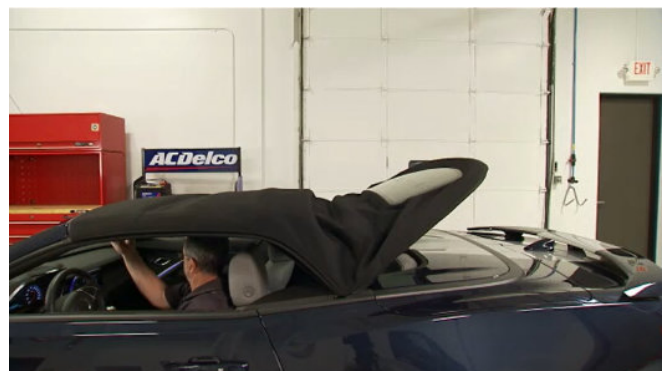
Example Case: Let's take a 2018 Chevrolet Camaro for instance, with a basic folding top concern. The customer states that the top will open fine, but it will not close all the way. A preliminary check will indicate that there is a "Top Not Secure" message in the DIC, but no DTCs are set. The tech is able to duplicate the concern each and every time. When closing, the top will lift up out of the stowage compartment, latch tightly to the windshield header, and the tension bow will lift up to a 45° angle. The Rear Stowage Compartment Lid will lower and lock into position, but the tension bow will not lower. It simply remains suspended in the air as seen in the photo below. The folding top pump quits working and the top stops moving at that point.

On a correctly working car, the stowage compartment lid must close completely before the tension bow is commanded down. Because the steps or phases must be completed in order, the technician must go to the point where the failure occurs, and then go back one step to look at the scan tool data.

can see that only one of the two Stowage Compartment Lid Closed Position Sensors read "On". Because the Folding Top Control Module will not command the tension bow to lower if both Stowage Compartment Lid Closed Position Sensors are not showing that they are closed, the module thinks that the stowage lid is still raised. As a matter of operation, it will not continue the top cycle. In this instance, the technician must further inspect the Right Folding Top Stowage Compartment Lid Closed Position Sensor to determine what the fault is.
