2020 - 2021 Corvette - Service Update Bulletin: #N212327740: Service Update - HVAC Condensate Drain Hose Not Fully Installed - (Mar 10, 2021)

Subject: N212327740 — HVAC Condensate Drain

Hose Not Fully Installed

Models: 2020 – 2021 Chevrolet Corvette

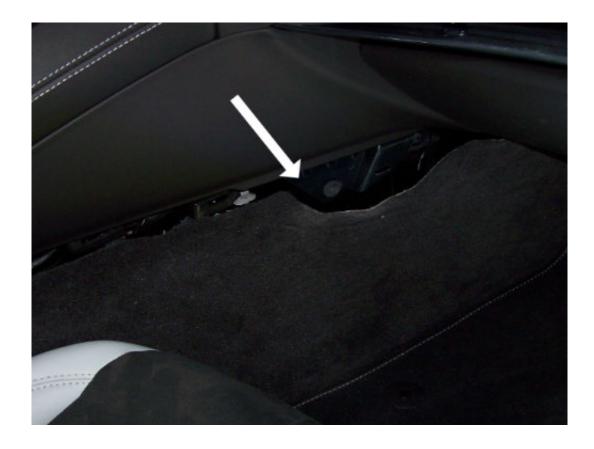
1. Remove the Front Floor Rear Console Side Trim Panel – Right Side. Refer to *Front Floor Rear Console Side Trim Panel – Right Side* in SI.

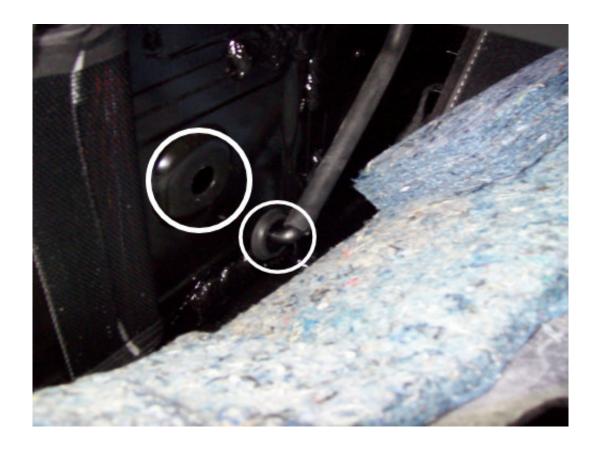
2. Pull back the carpet in the location shown to gain access to the A/C Evaporator Drain Tube.

- 3. The drain tube may be partially or fully disconnected from the body sheet metal as shown.
- If the drain tube end is fully disconnected, reinsert the drain tube end into the body sheet metal and press firmly to be sure it is securely fastened.
- If the drain tube end appears to be correctly seated in the body sheet metal, press firmly on it to confirm that it is securely fastened.
- Shift the carpet back to the original location.
- Reinstall the Front Floor Rear Console Side Trim Panel Right Side. Refer to *Front Floor Rear Console Side Trim Panel Right Side* in SI.
