2014 - 2021 Corvette: Service Buletin: #PIP5212C: Concern Of An Engine Thermostat Tick Noise And/Or Running Hot - (Mar 30, 2021)

#PIP5212C: Concern Of An Engine Thermostat Tick Noise And/Or Running Hot - (Mar 30, 2021)

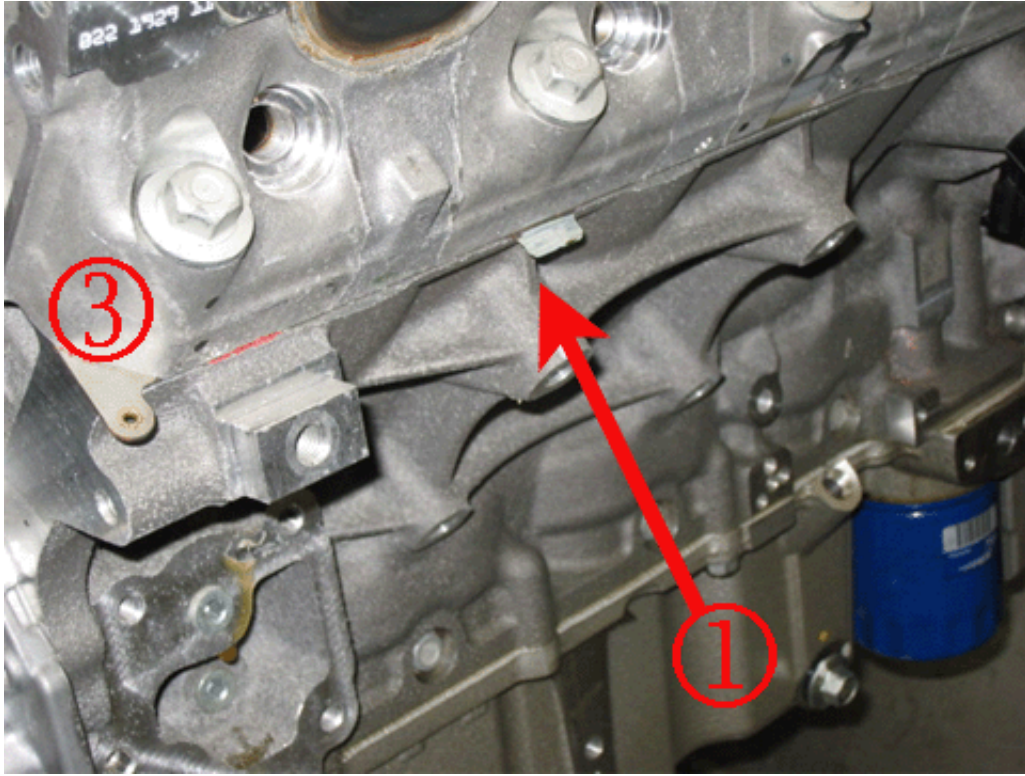
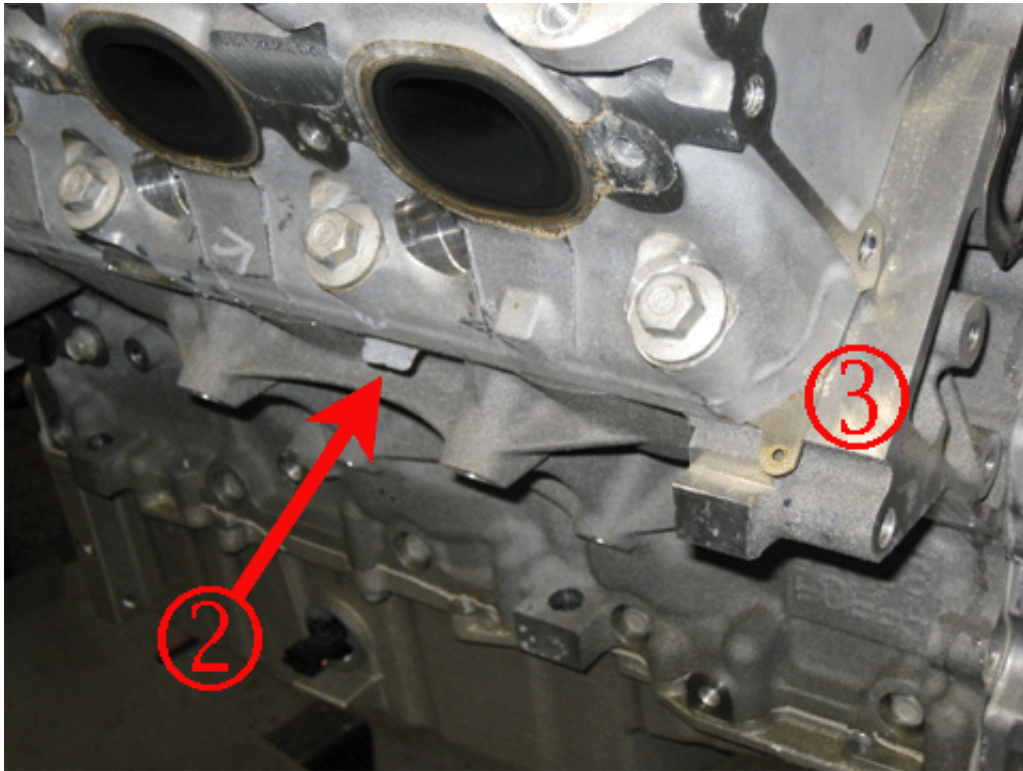
Per the attached pictures, the head gasket locating tabs for both of the engine cylinder banks should be toward the front of the engine.

1. Bank 1 tab near cylinder 3

2. Bank 2 tab near cylinder 4

3. Is the front of the engine

If the head gasket locating tabs are found to be closer to cylinders 5 or 6, this indicates the head gaskets were installed incorrectly restricting the engine coolant flow.

Replace the head gasket to repair for this concern.
