2020 - 2021 Corvette: Service Bulletin: #21-NA-091: Information on Normal Rearview Camera Display Operation - Flashing Diamond - Spot - or UFO like image on Rear View Camera Display - (Apr 13, 2021)

Subject: Information on Normal Rear View Camera Display Operation - Flashing Diamond - Spot - or UFO like image on Rear View Camera Display

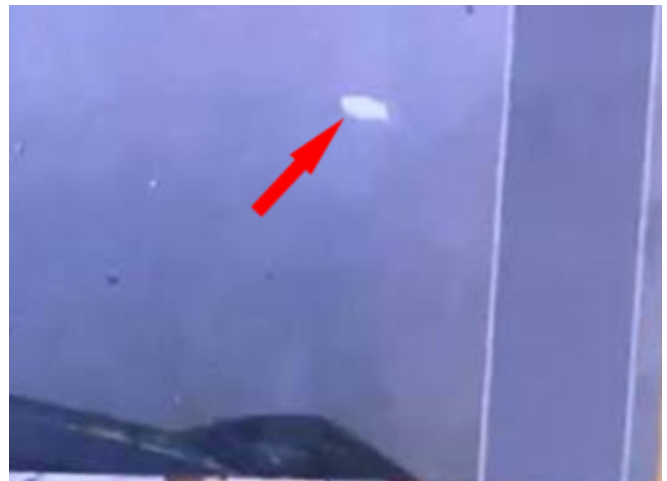
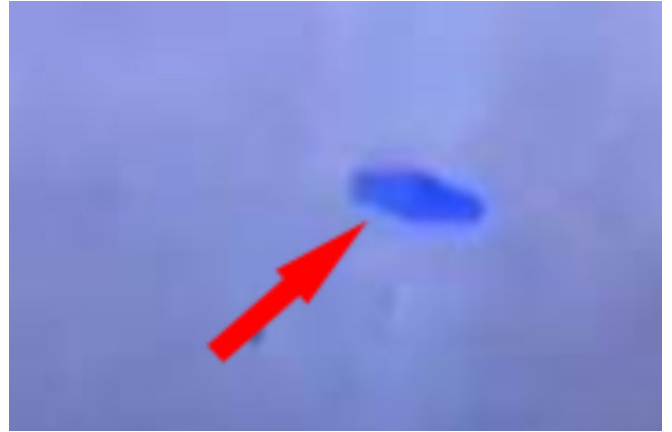
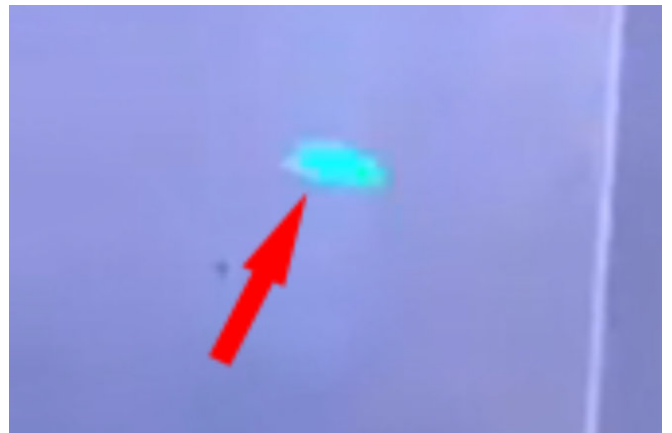
Some customers may comment on a flashing light present on the radio display when in Reverse and with the rear view camera on, usually is corrected by an ignition cycle.

Please communicate to the customer that the rear view camera system and radio display are functioning as designed and this is a normal condition of their vehicle. Please share this information with the customer, including a copy of this bulletin.

Technicians should verify that no other conditions are present and return the vehicle to the customer.
