1989 - 1996 Corvette: Service Bulletin: Information on Corvette ZF 6-Speed Manual Transmission Service Procedure

Model Year: 1989-96 CHEVROLET CORVETTE WITH ZF 6-SPEED MANUAL TRANSMISSION (ML9)

Bulletin Number: 77-72-04

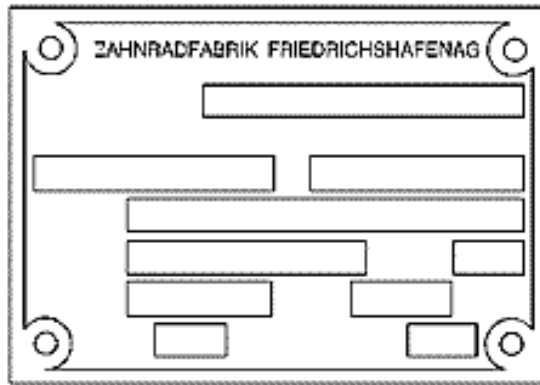
Figure 2

INPUT SHAFT LENGTH

ENGINE TYPE	"L" mm (in)
L98	159.5 (6.28)
LT5	190.5 (7.50)

TRANSMISSION LEAKS A) INPUT SHAFT LEAKS REPLACE INPUT SHAFT BEARING RETAINER ASSEMBLY, O-RING AND GASKET. FRONT INPUT BEARING ENDPLAY

SHOULD BE CHECKED AND RE-SHIMMED IF NECESSARY, PER PROCEDURE IN SHOP MANUAL. (SEE ILLUSTRATION) KENT MOORE SPECIAL TOOL #J38126 NEEDED FOR O- RING REPLACEMENT. IMPORTANT: BEARING RETAINER FOR L98/LT1 AND LT5 ENGINE IS NOT INTERCHANGEABLE.
