16038 Transmission Oil Cooler Line in Contact with Body Stud

Reference Number: N162051960 Release Date: January 2017

Revision: 00

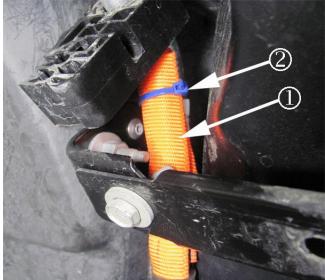
4673809

Caution: Ensure the protective sleeve is orientated so the opening in the sleeve is away from the body bolt.

Note: The tie strap and protective sleeve will be different colors than what is shown. The sleeve and tie strap shown in this picture are for illustrative purposes only.

- 4. Install the protective sleeve (1) onto the transmission fluid auxiliary cooler inlet rear intermediate pipe.
- 5. Install the tie strap (2) around the protective sleeve and cinch the tie strap.
- 6. Cut the excess off of the tie strap.
- 7. Install the driver side rear wheelhouse liner. Refer to Rear Wheelhouse Liner Replacement in SI.
- 8. Lower the vehicle. Refer to Lifting and Jacking the Vehicle in SI.
