1954 Corvette: Service Bulletin: Engine Valve Noise

Subject: Engine Valve Noise

Model and Year: 1954 Powerglide Engines

Bulletin No: DR - 168

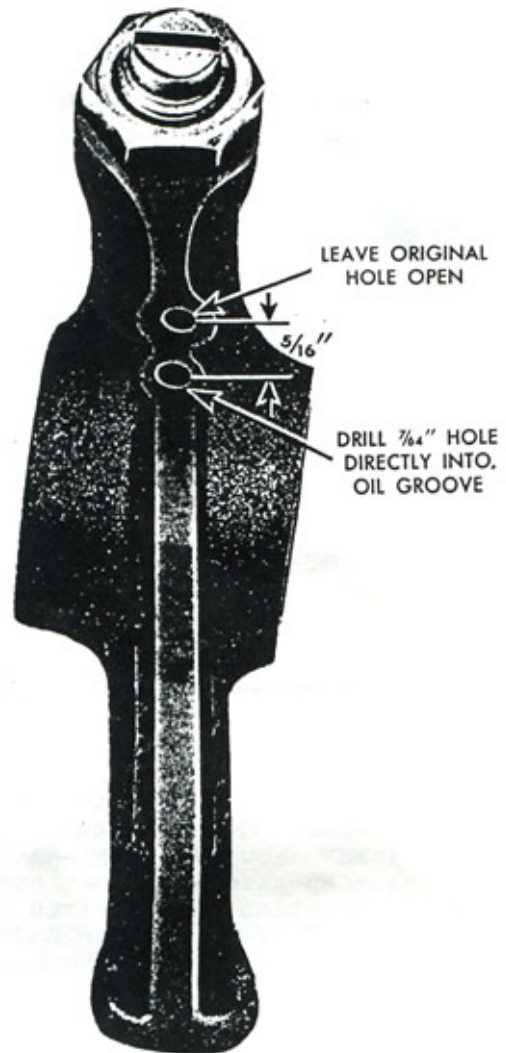
INLET

Identification - reinforcing rib on each side of arm.

Drill an additional $7/64$ " hole in the rib $5/16$ " toward the rocker arm pad from the original oil hole.

This hole should be drilled directly into the oil groove.
