1954 Corvette: Service Bulletin: Engine Valve Noise

Subject: Engine Valve Noise

Bulletin No: DR - 168

Date: April 8, 1954

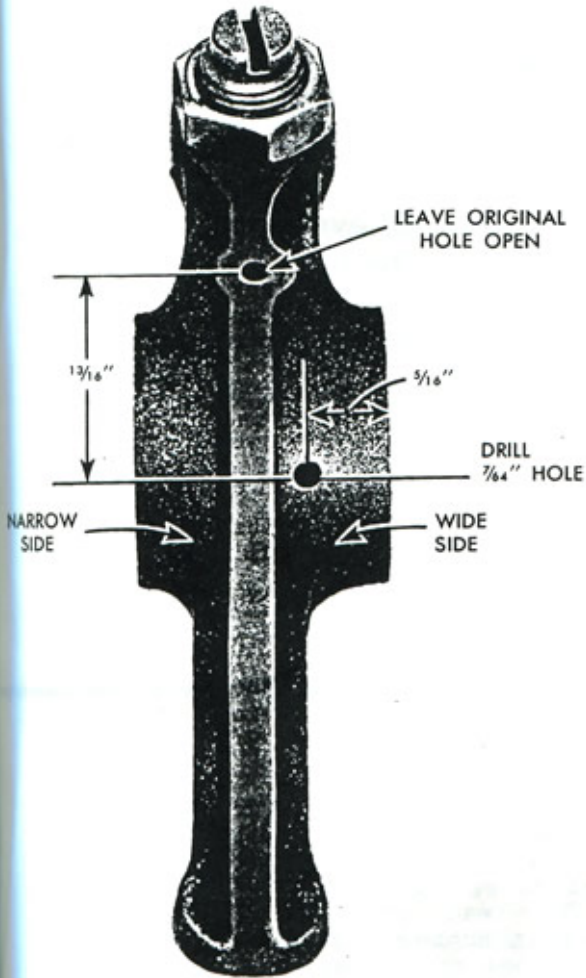
EXHAUST

In cases where valve squawk exists on 1954 Powerglide Engines, the rocker arms may be drilled as outlined below to provide additional lubrication between the rocker arm and valve stem also a slight increase at the valve stem and guide.

Drill an additional $7/64$ " hole in the wide side of the rocker arm bearing boss, measuring $13/16$ " in a straight line toward the pad from the existing oil hole and $5/16$ " in from the edge on the wide side of the bearing boss.

Caution: This hole should be drilled straight in but must not break into the oil groove in the rocker arm bearing.

Carefully remove all burrs on the inside so as not to effect the bearing area.
