# 2014 - 2015 Corvette: GM TechLink: 6.2L Engine Bell Housing Rattle

**Subject:** 6.2L Engine Bell Housing Rattle

**Model and Year:** 2014 - 2015 Corvette Equipped with LT1

**Source:** GM TechLink

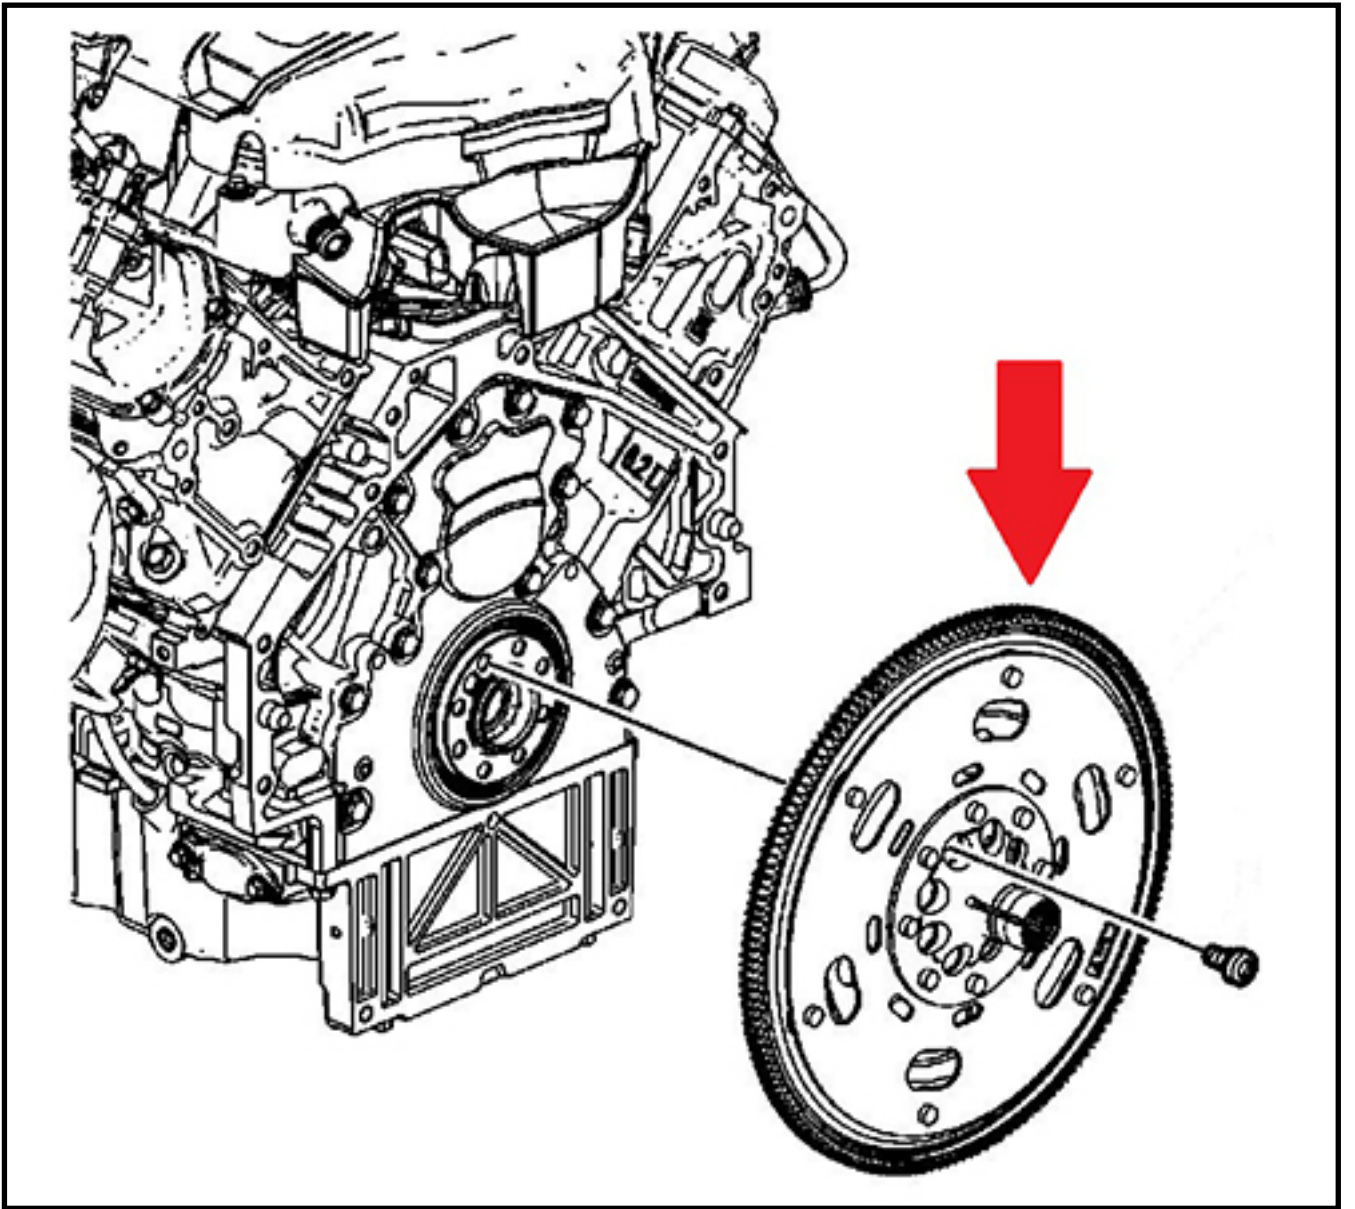
Follow the appropriate Service Information diagnostic procedures to determine if the rattle noise is coming from the Driveline Support Assembly (DSA) or the transmission flex plate. If the rattle is coming from the flex plate, it will only be heard at idle from the front of the vehicle while in Park.

If it's determined that the rattle noise is coming from the flex plate (Fig. 7), raise the vehicle on a hoist and pull the front bell access cover. The noise will be coming from the hole.

**TIP:** Check that the pinch clamp bolt is tight before replacing the front flex plate. The loose bolt condition results in the same noise. This is an easy check before starting a major service procedure.

Do not reinstall the old flex plate even if it looks OK as the cause of the rattle may not be visible.

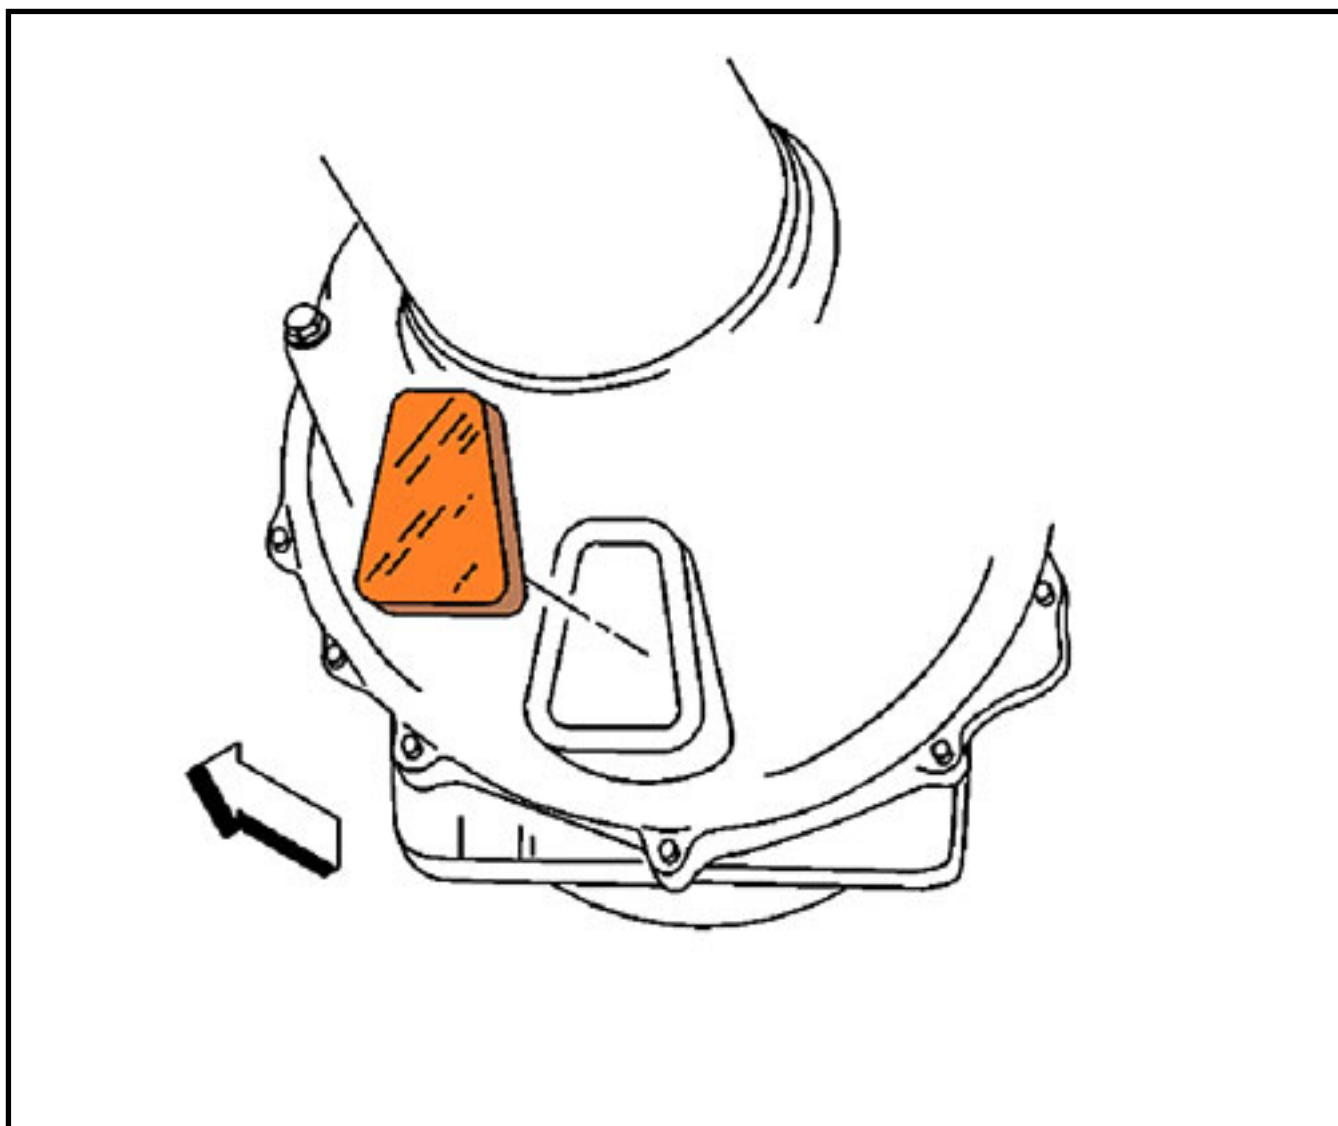
Unlike the flex plate rattle, a DSA rattle noise typically occurs at or just off idle and will be louder when observed via the rear bell housing access plug. (Fig. 8)

When performing repairs for a flex plate rattle or DSA rattle, refer to the

latest information in the Service Information:

- #13-04-17-001 – Driveline Support (Torque Tube) / Propeller Shaft Input to Front Hub Bearing Alignment
- Document ID 3973764 – Driveline Support Assembly Replacement (with Automatic Transmission)
