# 1970 Corvette: Service Bulletin: Water Pump Bearing and/or Shaft Failures

**Bulletin No:** 71-T-37

**Date:** June 23, 1971

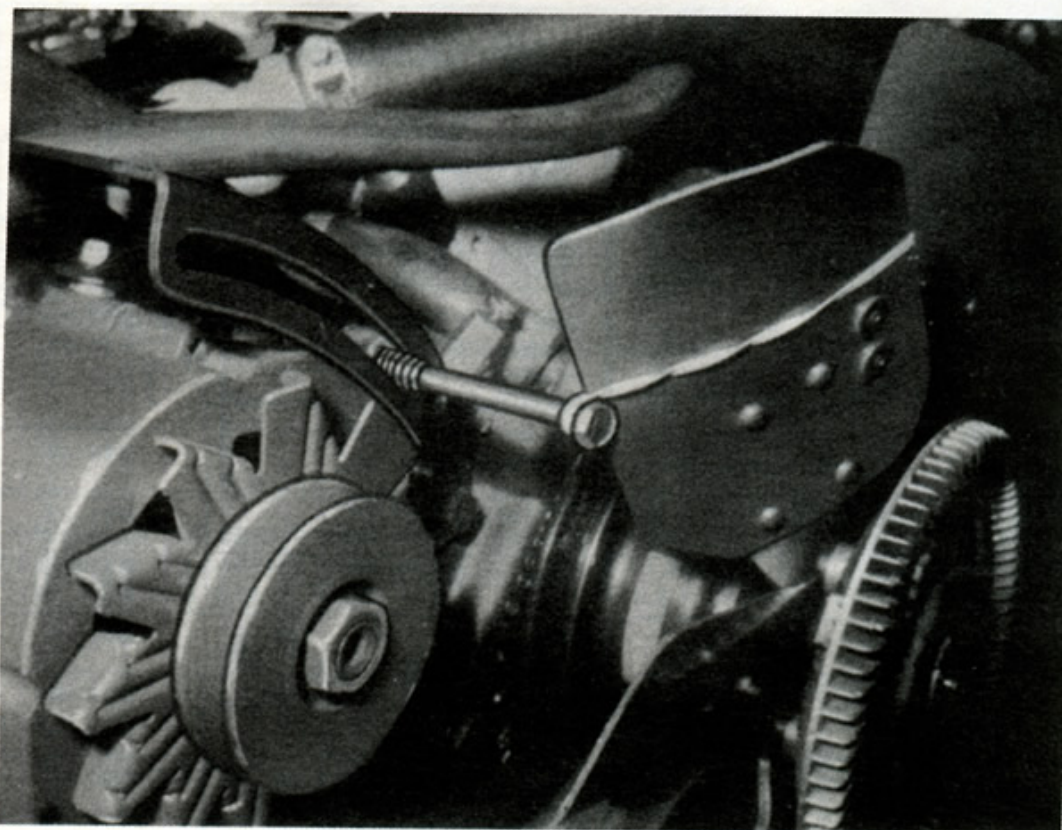
FIGURE-1

Investigation has shown that water pump bearing and/or shaft failures may occur if excessive run-out exists at the fan clutch.

- A. Secure the fan blade to prevent rotation. (See Figure 1).
- B. Mount a dial indicator (.001 graduations) to the engine and place the indicator pointer on the fan blade spider. Preferably on the longest
