1963 Corvette: Service Bulletin: Interim Production Changes

Subject: Interim Production Changes
Model and Year: 1963 Corvette
Source: Chevrolet Technical Service Bulletin
Bulletin No: DR #569
Section: XV
Date: December 31, 1962

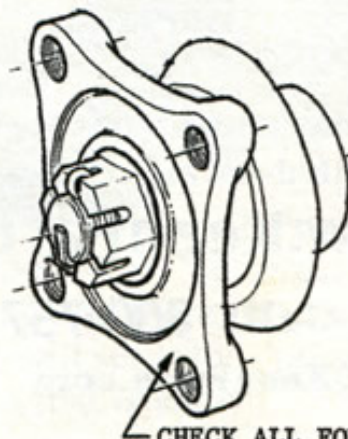
FIGURE 4 - SPINDLE FLANGE

CHECK ALL FOUR
BOSSES FOR CRACKS
IN THIS AREA

Replacement of the driveshaft flange is covered in the 1963 Corvette Shop Manual, Page 4-16. The rear wheel spindle flange attaching bolt bosses should be visually inspected while the axle driveshafts are out of the vehicle. Replace with new Spindle Flange Assembly No. 3830253 if any cracks are evident in the area indicated in Figure 4.

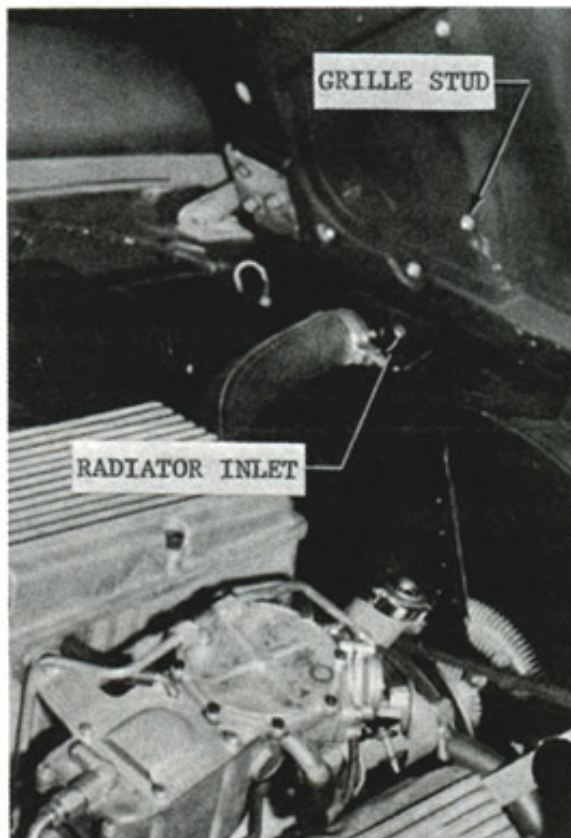
FIGURE 4

3. Vehicles prior to Serial No. S105362 may have interference between the radiator top tank inlet and one of the simulated hood grille attaching studs. Contact at this point might eventually rub through the radiator inlet causing loss of water and cooling system pressure.

All vehicles built prior to Serial Number S105362, may have interference between the hood simulated grille attaching stud indicated in Figure 4, and the radiator inlet. To eliminate possible radiator damage, the following steps should be followed:

1. File or grind stud off flush with lower face of nut.
2. Inspect radiator inlet for any signs of leakage in the area of stud contact.
3. Place a small thin piece of body sealer or clay on radiator inlet and close hood. Open hood and inspect sealer or clay to determine if metal to metal contact still exists. If necessary, carefully tap a small depression in radiator inlet using a ball peen hammer and recheck clearance with sealer or clay.
