1963 Corvette: Service Bulletin: Interim Production Changes

Subject: Interim Production Changes
Model and Year: 1963 Corvette
Source: Chevrolet Technical Service Bulletin
Bulletin No: DR #569
Section: XV
Date: December 31, 1962

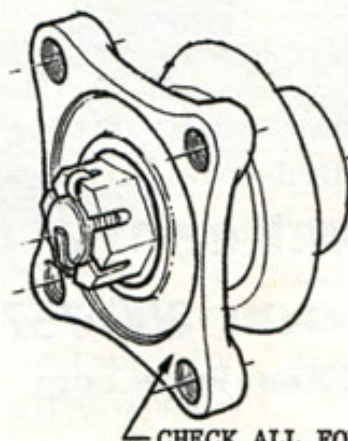
FIGURE 4 - SPINDLE FLANGE

CHECK ALL FOUR
BOSSES FOR CRACKS
IN THIS AREA

Replacement of the driveshaft flange is covered in the 1963 Corvette Shop Manual, Page 4-16. The rear wheel spindle flange attaching bolt bosses should be visually inspected while the axle driveshafts are out of the vehicle. Replace with new Spindle Flange Assembly No. 3830253 if any cracks are evident in the area indicated in Figure 4.
