# 2014 Corvette: GM TechLink: Steering Pull at Highway Speeds

**Subject:** Steering Pull at Highway Speeds

**Model and Year:** 2014 Corvette

**Source:** GM TechLink

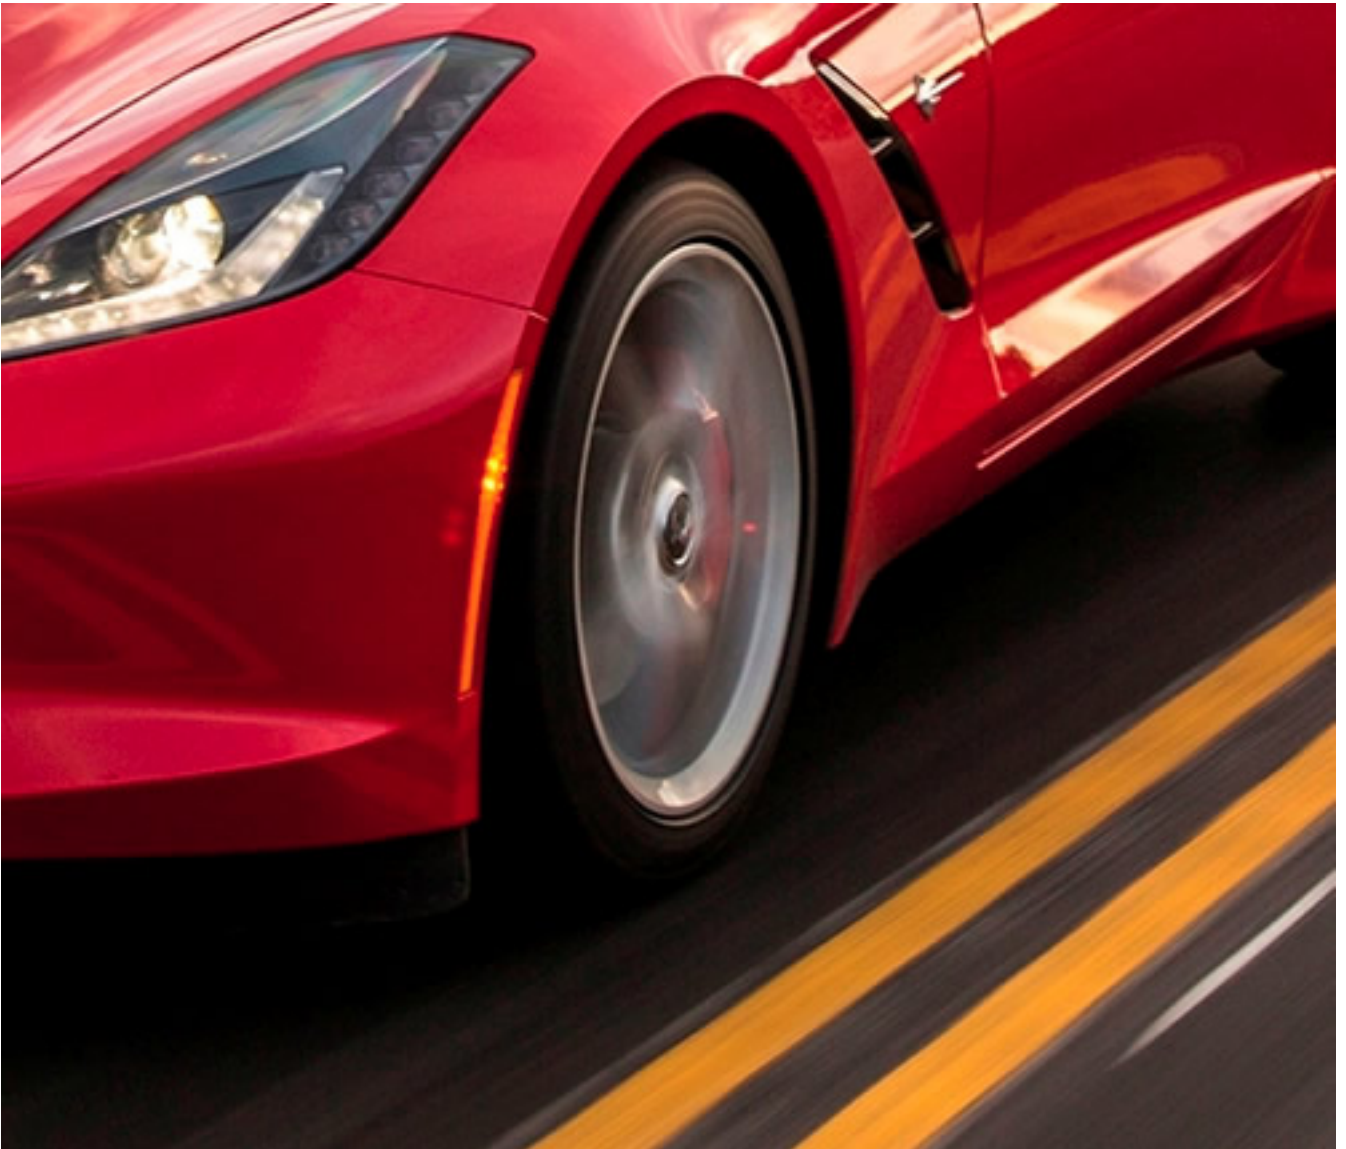
**Fig. 6**

On some 2014 Corvettes, the steering may pull to the right while driving at highway speeds. (Fig. 6)
