# 1984 - 1985 Corvette: Service Bulletin: Noise in Direct Drive 4-Speed Manual Transmission

**Source:** Chevrolet Dealer Service Bulletin

**Bulletin No:** 85-111

**Date:** Aug., 1985

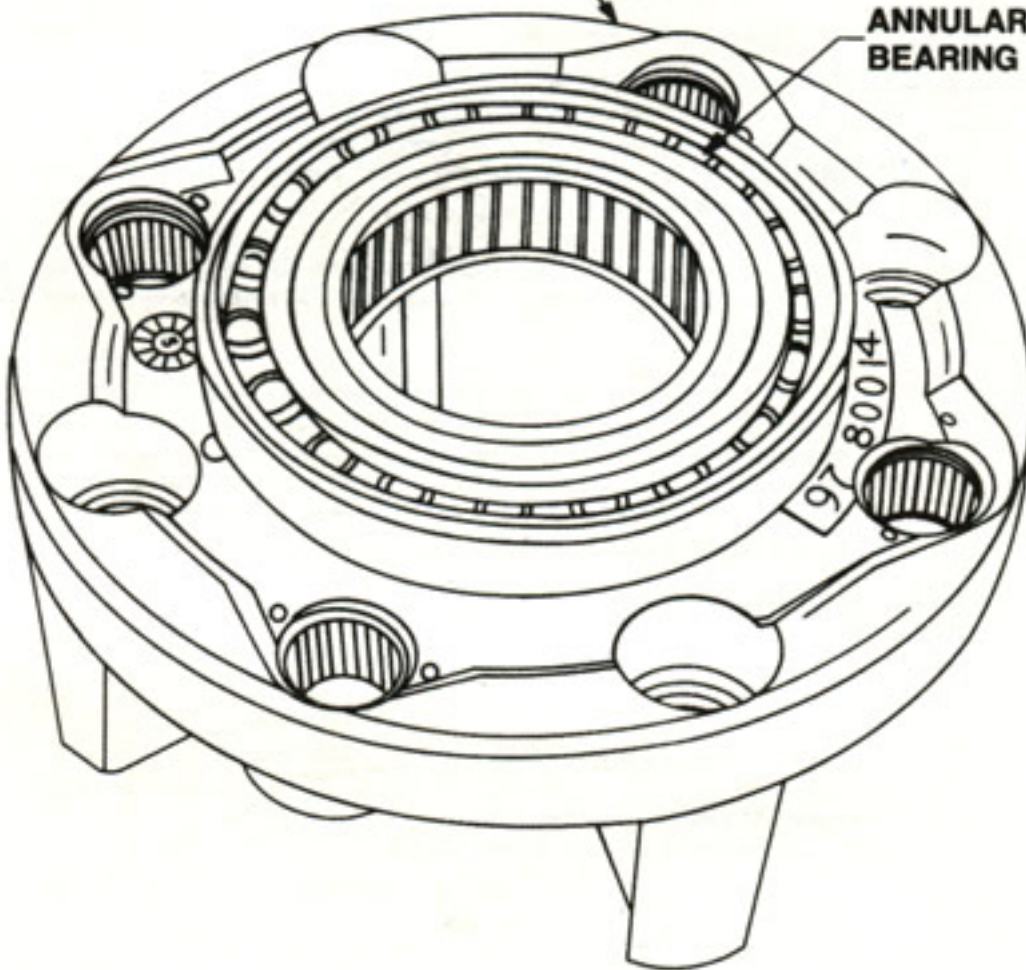
**Figure 1**

This condition may be caused by a worn annular bearing on the planetary gear carrier (see illustration). Continued operation of a noisy transmission in the direct drive model will cause damage to the planetary carrier, adapter plate, input sun gear, and input sun gear oil seal. If the input sun gear oil seal is damaged, it is possible for overdrive unit oil (Dexron II) to leak into the manual portion of the transmission.

On transmissions beginning with serial number D5C 14413 CF, a new planetary gear carrier has been released. This carrier (P/N 14094571) incorporates an annular bearing with increased thrust capacity.

1. Inspect the adapter plate surface, input sun gear, and input sun gear oil seal for damage. If there is indication of damage, the adapter plate, input sun gear, and input sun gear oil seal should be replaced. If there is no sign of damage, these parts may be reused.
2. If debris is present in the overdrive unit, completely disassemble and clean the unit, including the valve body. Thoroughly flush the cooler lines to remove any debris following the procedure outlined in the Vehicle Service Manual. Replace the oil filter.
3. If there is evidence of oil intrusion from the automatic overdrive unit into the 4-speed manual unit, the manual unit should be drained and flushed also.
4. Replace the planetary gear carrier with the new, P/N 14094571, carrier.

**NOTICE:** When an overdrive unit from a transmission built prior to serial number D5C 14413 CF is disassembled for any reason, it is recommended that a new, P/N 14094571, planetary gear carrier be installed to prevent potential future annular bearing failures.
