# 1962 Corvette: Service Bulletin: Aluminum Powerglide Shift Problems

**Source:** Chevrolet Technical Service Bulletin

**Bulletin No:** DR #514

**Date:** January 16, 1962

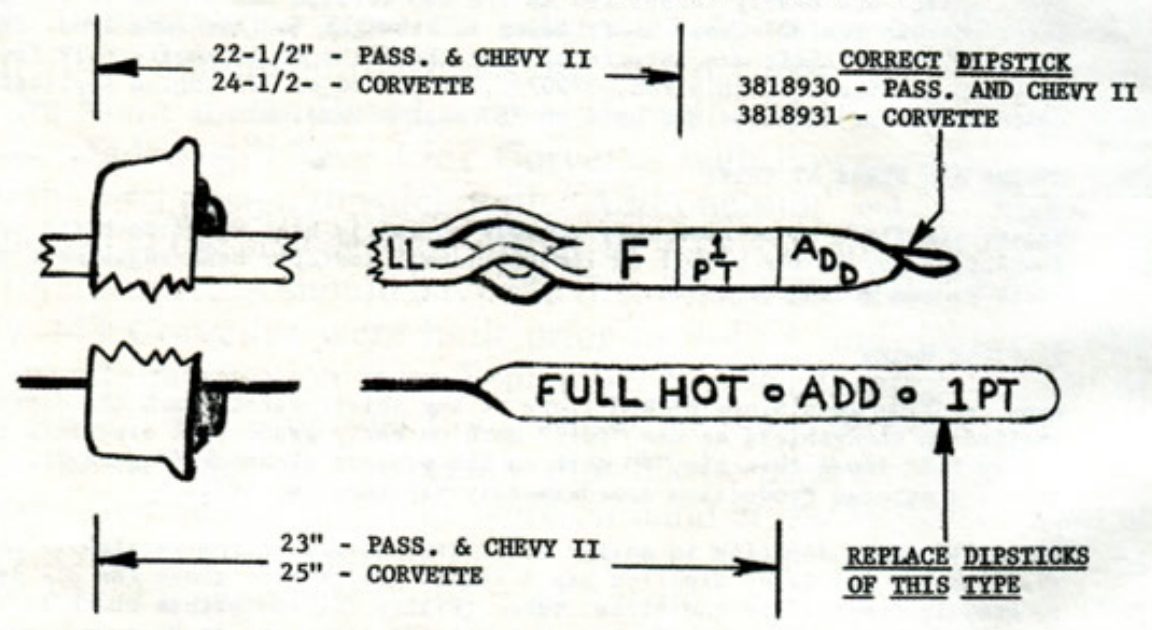
FIGURE 2 - ALUMINUM POWERGLIDE DIPSTICKS

When checking complaints of RPM flare at the shift, first check the dipstick installed in the vehicle as the "Full" mark on early production dipsticks is approximately 1/2" lower than the "F" mark on the present dipstick (Figure 2). The later dipstick entered Production approximately September 4, 1961.

The early style dipstick is easily identified as its bottom section is absolutely flat whereas the later dipstick has a formed bridge just above the oil level markings to keep it centered in the filler tube. (Figure 2). A further check is to measure the distance from the top of the cap to the "Full" mark; on

Passenger and Chevy II dipsticks, this distance is now 22-1/2", as compared to 23" on the earlier dipsticks. This distance on the Corvette dipstick is now 24-1/2" as compared to 25" on earlier units.

Replace all early dipsticks with the later part when found and add oil as

required to raise the transmission oil level to the "F" mark. The later dipstick for 327 engine passenger cars and all Chevy II Models is 3818930; for Corvette, 3818931.
