1964 Corvette: Service Bulletin: Neutral Safety Switch Malfunction

Model and Year: 1964 Corvettes with Powerglide Transmissions

Source: Chevrolet Technical Service Bulletin

Bulletin No: DR #658

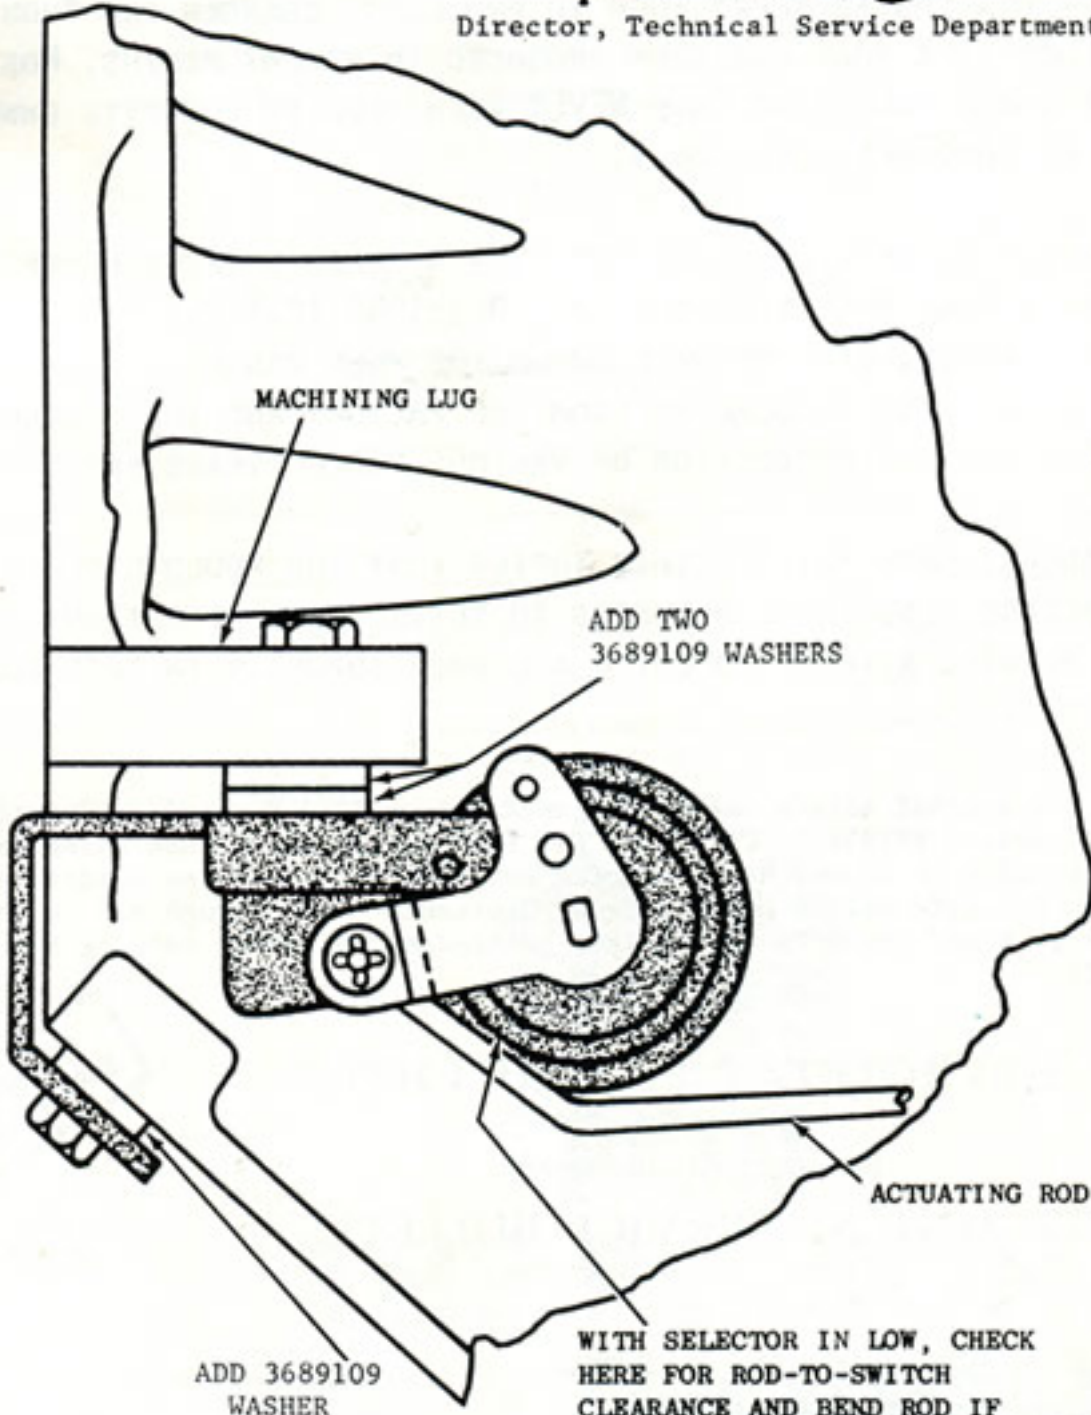
Interference between the neutral safety switch and the underbody may exist on some early production Corvette Models with Powerglide transmissions.

This could result in the engine being started while the transmission selector is in a drive position. In addition, the added load imposed on the shift linkage by the misalignment causes a reduction or loss of detent feel when the transmission is shifted manually. The transmission might then be accidentally operated between ranges and internal damage could result.

Correction of switch malfunction may be made by shimming the switch assembly downward as shown in the attached sketch. Note that operating clearance must exist between the switch body and the switch actuating rod after the shimming operation is completed.

WITH SELECTOR IN LOW, CHECK HERE FOR ROD-TO-SWITCH CLEARANCE AND BEND ROD IF NECESSARY. TEST ACTION OF SWITCH AFTER BENDING ROD & ADJUST LENGTH OF ROD AS REQUIRED BY TURNING THREADED PIVOT.
