## 1997 - 1998 Corvette: Service News: Corvette Engine Low Coolant MIL

Subject: Corvette Engine Low Coolant MIL
Model and Year: 1997 - 1998 Corvette
Source: Chevrolet Pro Service News
Page Number: 2
Date: May 1998 - Volume 7 - Number 5

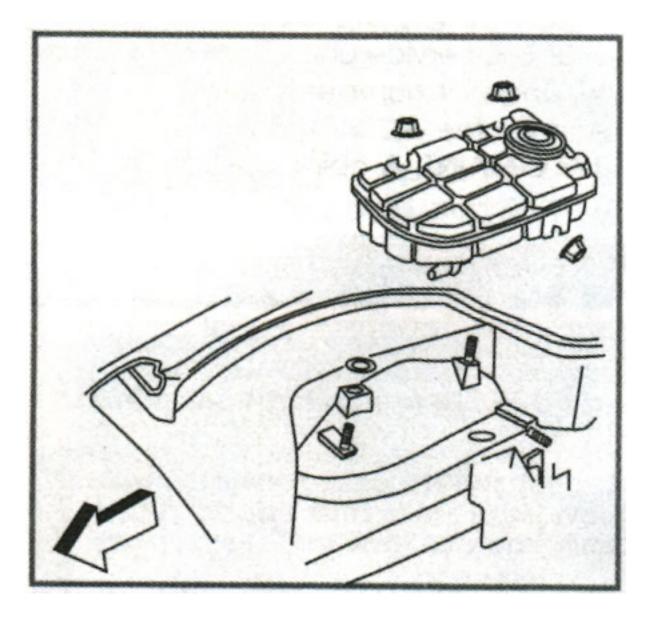
The engine low coolant MIL may come on intermittently on some 1997 - 1998 Corvettes. This condition may be due to the position of the radiator surge tank, and is more likely to occur when the engine is cold and when parked or driven going forward down a hill.

There are three mounting studs for the surge tank. The lower horizontal stud engages a slot in the tank. If the stud is not bottomed out in the slot, the tank will be tipped and affect the proper coolant level reading. To correct this condition, loosen all three attaching nuts and insure that the lower horizontal stud is fully seated in the slot. Tighten the bottom nut, followed by the two top nuts, to the proper torque.
