# 1968 Corvette: Service Bulletin: Cold Start Failure

**Subject:** Cold Start Failure

**Model and Year:** All 1968 Vehicles Incorporating V-8 Engines

**Bulletin No:** 68-T-31

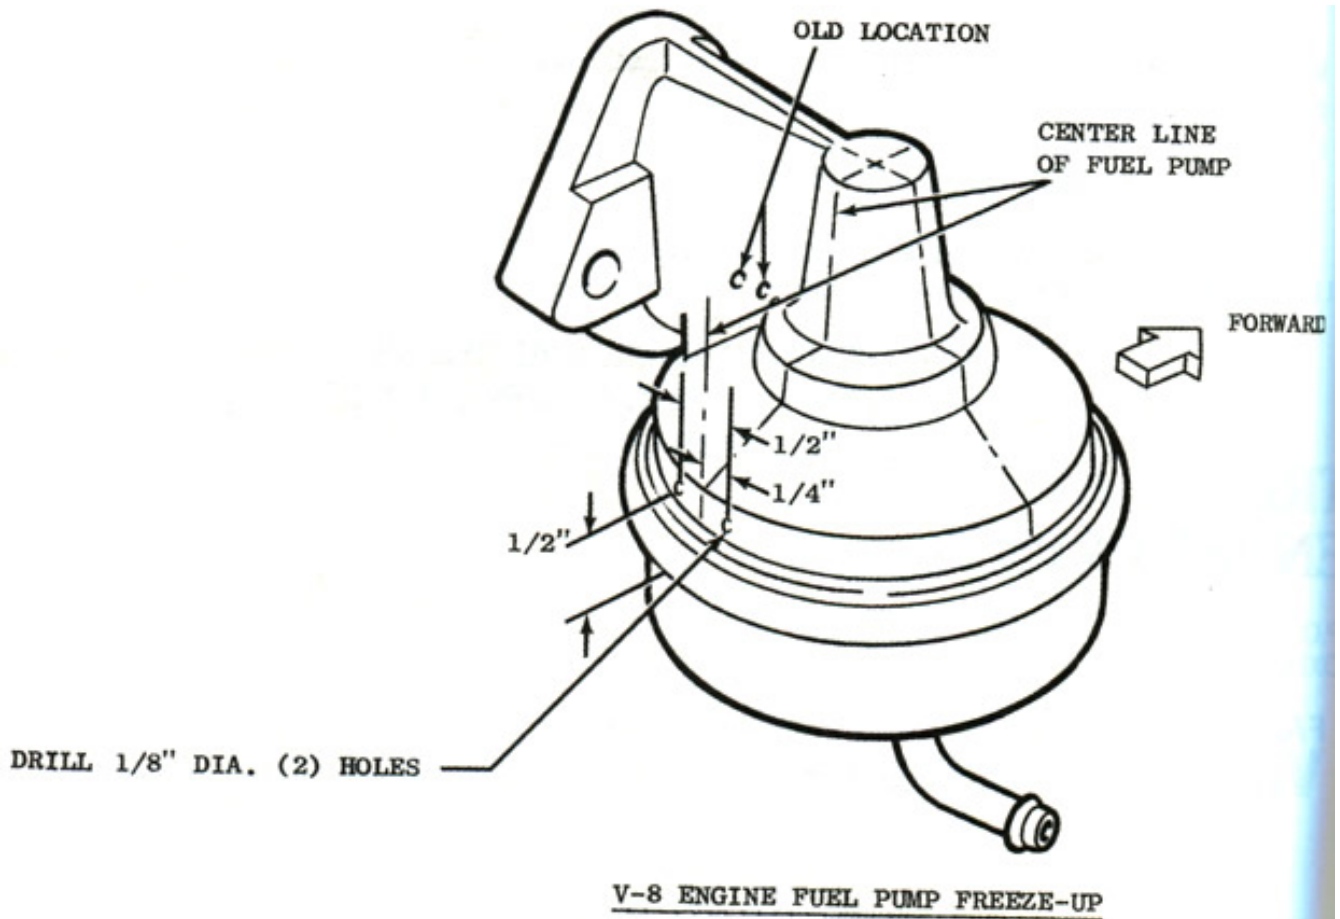
Incidents of fuel pump freeze-up and failing to supply fuel have been encountered on some 1968 vehicles equipped with V-8 engines. These failures usually occur in areas which encounter rain and overnight sub-freezing temperatures. The fuel pump becomes inoperative when water enters through the atmospheric vent holes and freezes.

To prevent the above condition and to provide a drain, all V-8 engine fuel pumps are being revised by relocating the atmospheric vent holes from near the mounting flange to near the crimp flange. Refer to Sketch on Page.

A good indication of this condition could be a fuel pump that operates satisfactorily in above-freezing temperatures, such as being stored inside, but does not operate after setting for a period of time in sub-freezing temperatures. A simple check can be made on vehicles not subjected to above-freezing temperatures by removing the air cleaner, stroking the throttle rod, and observing for fuel discharge into the carburetor venturi. If there is no fuel discharge, remove the fuel pump and allow it to thaw and drain. To prevent

recurrence, drill two 1/8" holes as shown in sketch.
