2014 Corvette: GM TechLink: Oil Leak after the Harmonic Balancer is Removed

Subject: Oil Leak after the Harmonic Balancer is Removed

Model and Year: 2014 Corvette

Date: December 17, 2014

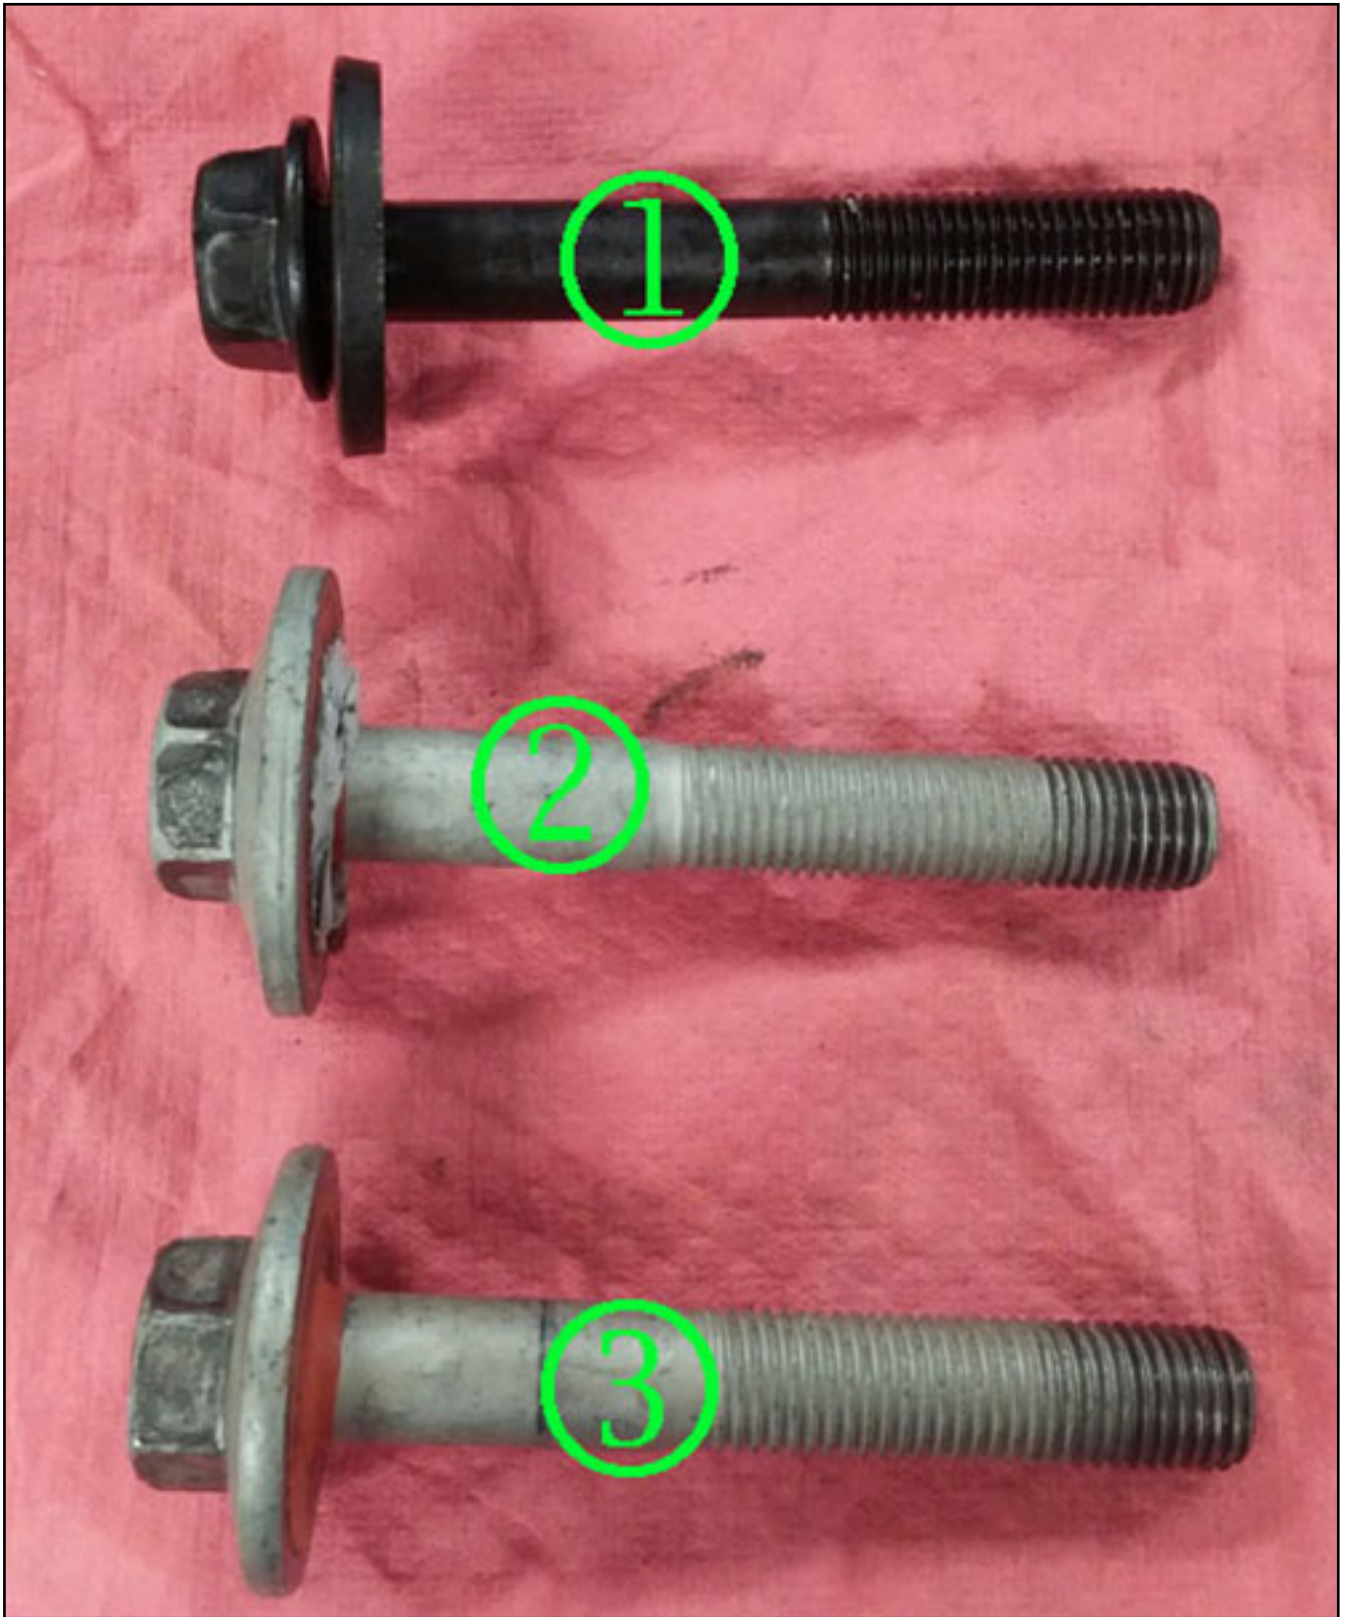
Fig. 24

If a Gen 4 bolt is used in a Gen5 engine, it will result in an oil leak.

The bolts (Fig. 24) shown below are:

Bolt 1– Gen 5 engine

Bolt 2 – Gen 5 engine
Bolt 3 – Gen 4 engine
