1961 Corvette: Chevrolet Product Engineering Technical Information: Spark Plug Electrode Interference With Piston

Subject: Spark Plug Electrode Interference With Piston
Model and Year: 1961 Corvette Models Equipped with Fuel Injection
Source: Chevrolet Service and Mechanical Department - Technical
Information - 1961 Product Data Book
Bulletin Number: Page 3-4 - Section VI - Group 2
Date: 7/8/61

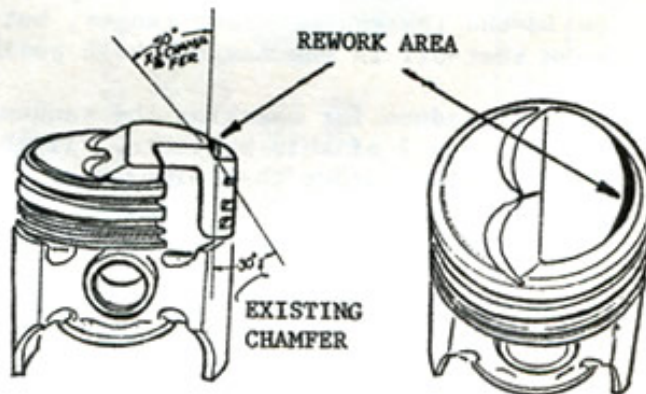
An interference condition between the spark plug ground electrode and piston dome may occur on 1961 Corvette Models equipped with fuel injection. This interference results in a bent electrode which causes insufficient spark plug gap, engine miss and subsequent poor performance.

Reworking Piston Dome - 1961 Corvette Models Equipped With Fuel Injection

The condition was corrected in Production effective 5-15-61 (engine date stamp F-0515) by removing 1/16" of the piston dome at the contact area as shown in the following sketch. The size of the area to be removed is approximately 1/16" thick, 1/8" wide and 1-1/2" long machined at a 50° angle. Only the top half of the dome chamfer should be removed with the lower portion remaining at the existing 30° angle.

In the event an 11:0-1 compression ratio engine equipped with fuel injection is being overhauled or if the cylinder heads are removed, each piston dome should be filed or ground off approximately 1/16" to prevent spark plug electrode interference. if only the heads are removed, the pistons should be at TDC and grease applied to the top of the pistons to insure complete remove of filings.
