# 1961 Corvette: Chevrolet Product Engineering Technical Information: Spark Plug Electrode Interference With Piston

**Subject:** Spark Plug Electrode Interference With Piston  
**Model and Year:** 1961 Corvette Models Equipped with Fuel Injection  
**Source:** Chevrolet Service and Mechanical Department - Technical  
Information - 1961 Product Data Book  
**Bulletin Number:** Page 3-4 - Section VI - Group 2  
**Date:** 7/8/61

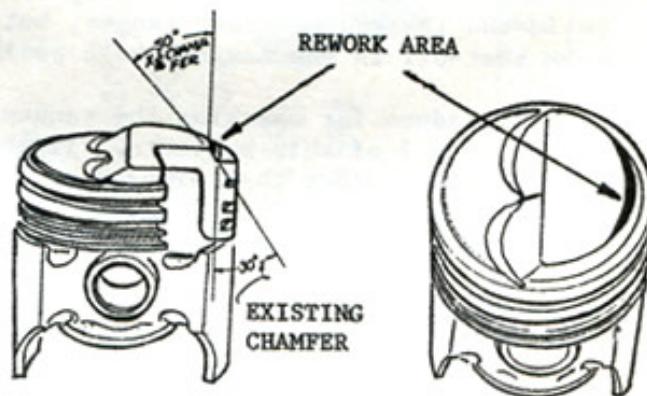
Reworking Piston Dome - 1961 Corvette Models Equipped With Fuel Injection

An interference condition between the spark plug ground electrode and piston dome may occur on 1961 Corvette Models equipped with fuel injection. This interference results in a bent electrode which causes insufficient spark plug gap, engine miss and subsequent poor performance.

The condition was corrected in Production effective 5-15-61 (engine date stamp F-0515) by removing 1/16" of the piston dome at the contact area as shown in the following sketch. The size of the area to be removed is approximately 1/16" thick, 1/8" wide and 1-1/2" long machined at a 50° angle. Only the top half of the dome chamfer should be removed with the lower portion remaining at the existing 30° angle.

In the event an 11:0-1 compression ratio engine equipped with fuel injection is being overhauled or if the cylinder heads are removed, each piston dome should be filed or ground off approximately 1/16" to prevent spark plug electrode interference. if only the heads are removed, the pistons should be at TDC and grease applied to the top of the pistons to insure complete remove of filings.
