1958 Corvette: Service Bulletin: Electric Windshield Wiper Information

Subject: Electric Windshield Wiper Information
Model and Year: 1958 Passenger Cars and Trucks
Source: Chevrolet Technical Service Bulletin
Bulletin No: DR #359
Section: I
Date: May 28, 1958

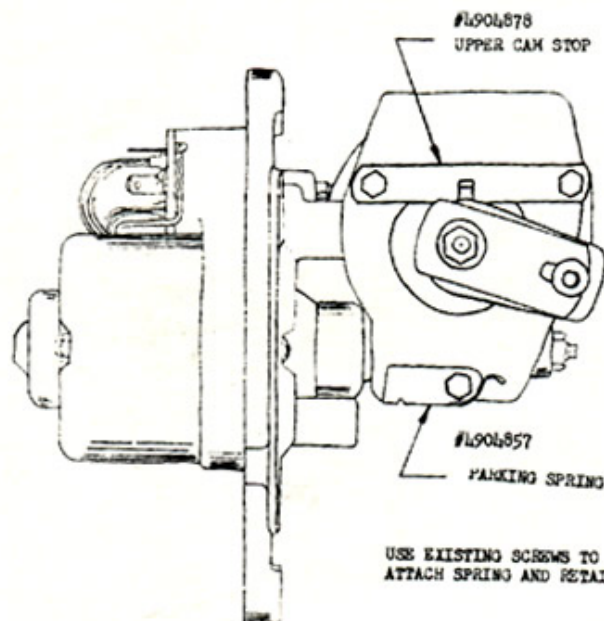
FIGURE #1.

In some cases the wiper motor, after being shut off, may over travel the effective length of the parking cam and continue to run in a reverse direction. This condition may occur even though the blades are properly positioned as covered in TSB #508, DR #359.

If the right hand blade slaps against the moulding excessively even though the blade is correctly positioned and parks properly, the upper cam stop is probably bent or broken. This damage can occur if the mechanism is coated with ice when the wiper is turned on.

SKETCH SHOWING INSTALLATION OF PARKING SPRING AND CAM STOP ON 1956 ELECTRIC WINDSHIELD WIPERS.

A parking spring has been released for production and service which enables the motor to shut off without depending on the resistance of the wiper blades. The spring is designed to clear the revolving arm in the "ON" position and stop the arm in the "PARK" position when switch is turned off. Figure #1 shows installation of parking spring.

A more durable replacement cam stop is available for service. Figure #1 shows details of installation. The existing tab must be bent flat before installation of the new stop.

Parking Spring and Cam Stop Unit
Includes: 1-4904857 - Parking Spring
1-4904878 - Cam Stop
