1958 Corvette: Service Bulletin: Electric Windshield Wiper Information

Subject: Electric Windshield Wiper Information
Model and Year: 1958 Passenger Cars and Trucks
Source: Chevrolet Technical Service Bulletin
Bulletin No: DR #359
Section: I
Date: May 28, 1958

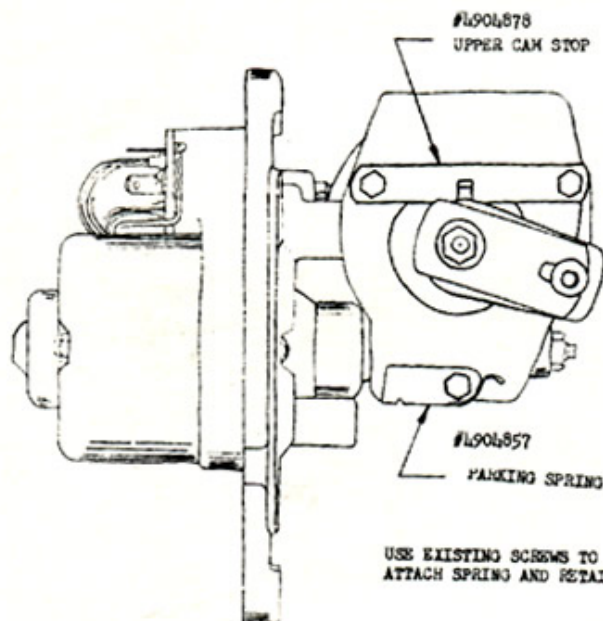
FIGURE #1.

In some cases the wiper motor, after being shut off, may over travel the effective length of the parking cam and continue to run in a reverse direction. This condition may occur even though the blades are properly positioned as covered in TSB #508, DR #359.

If the right hand blade slaps against the moulding excessively even though the blade is correctly positioned and parks properly, the upper cam stop is probably bent or broken. This damage can occur if the mechanism is coated with ice when the wiper is turned on.

SKETCH SHOWING INSTALLATION OF PARKING SPRING AND CAM STOP ON 1956 ELECTRIC WINDSHIELD WIPERS.

A parking spring has been released for production and service which enables the motor to shut off without depending on the resistance of the wiper blades. The spring is designed to clear the revolving arm in the "ON" position and stop the arm in the "PARK" position when switch is turned off. Figure #1 shows installation of parking spring.

A more durable replacement cam stop is available for service. Figure #1 shows details of installation. The existing tab must be bent flat before installation of the new stop.
