1957 - 1965 Corvette: Service Bulletin: Diagnosis and Fitting Main and Rod Bearings

Subject: Diagnosis and Fitting Main and Rod Bearings

Source: Chevrolet Technical Service Bulletin

Bulletin No: DR #742

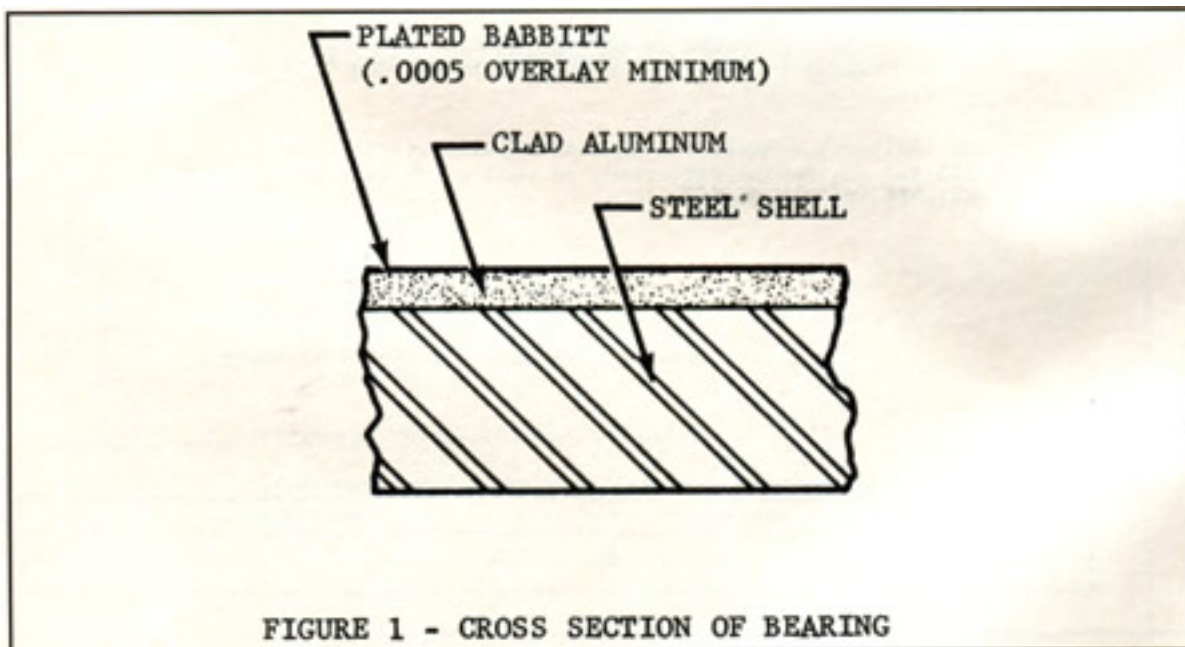
The babbitt overlay on the bearing faces (See Fig. 1) can be as thin as .0005 and in normal short mileage this can be removed from limited areas. This can cause a difference in color or appearance in the bearing face which is sometimes mistaken for being defective bearings.

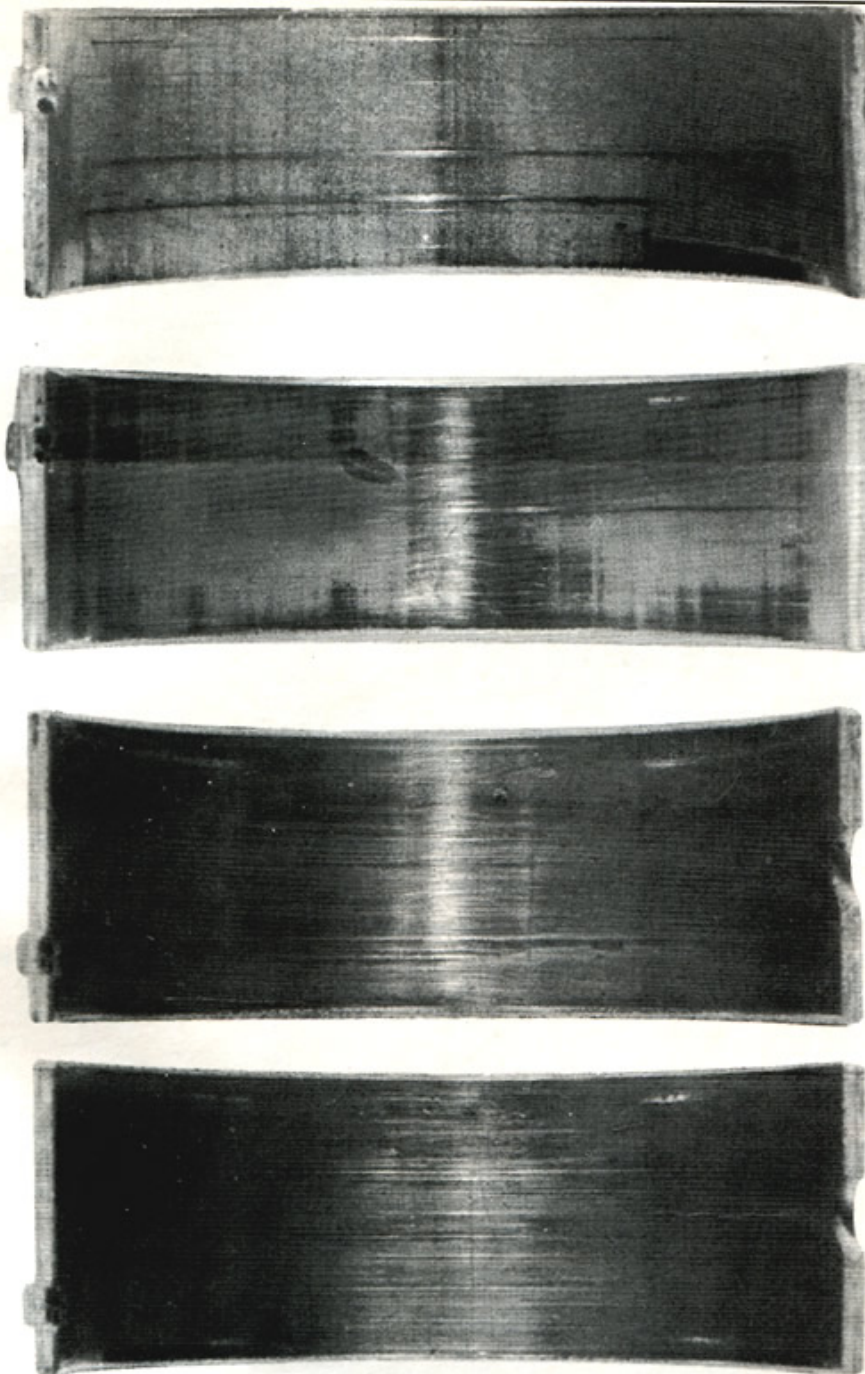
FIGURE 2 - BEARING WEAR PATTERNS

The bearings shown in Figure 2 have been operated for a short period of time, fitted within specified clearances and show initial wear patterns. This includes examples of minor scratches resulting from minute particles being circulated with the lubricant into the bearing clearance space. This type of wear is considered acceptable and has no detrimental effect on the function of the bearing. Extended operation will complete the wear pattern over the entire surface of the bearings.

When servicing crankshaft bearings, it is essential to use plastigage as outlined in the 1965 Shop Manuals to determine the actual clearance of the bearings. Also, it is important to understand and properly diagnose bearing wear patterns.
