1963 - 1965 Corvette: Service Bulletin: Drive Line Noise

Subject: Drive Line Noise

Source: Chevrolet Technical Service Bulletin

Bulletin No: #1069

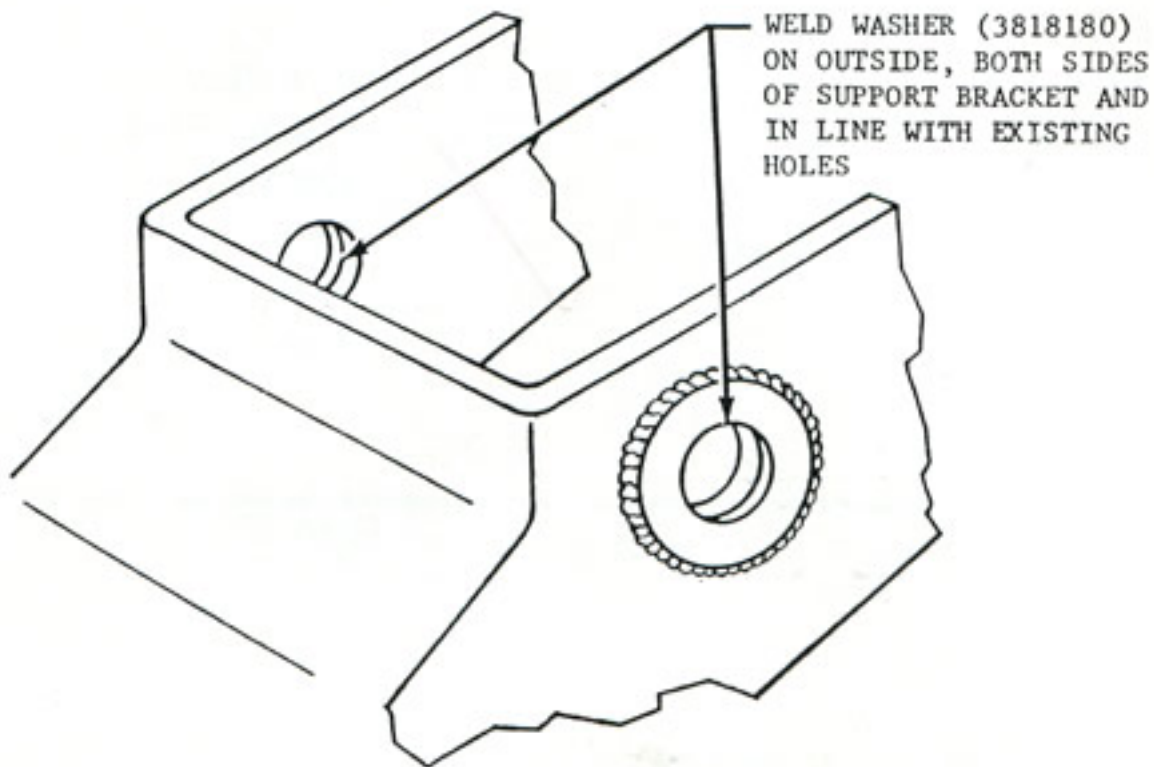
FIGURE 1

A clunking noise may occur in the drive line of some 1963-65 Corvette on initial vehicle movement in either forward or reverse gear. This could be caused by loosening of the differential carrier support bracket front attaching bolts. Loosening of these bolts will also result in elongation of the bracket bolt holes.

1. If reinforced bracket, Part No. 3868799 is not available, obtain Part No 3820186 and weld one flat washer, (Part No. 3818180) on each outside surface in line with existing holes (See Figure 1.)
