1963 - 1965 Corvette: Service Bulletin: Drive Line Noise

Subject: Drive Line Noise
Model and Year: 1963 - 1965 Corvette
Source: Chevrolet Technical Service Bulletin
Bulletin No: #1069
Section: IV
Date: January 7, 1965

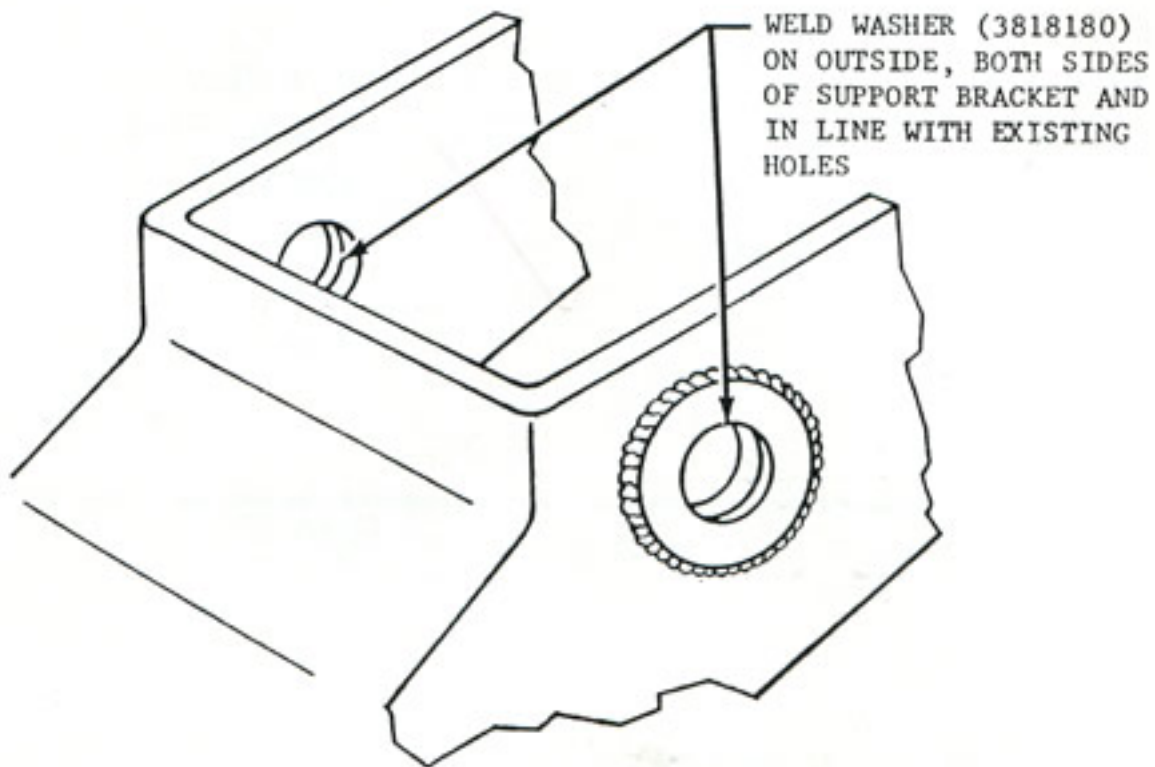
FIGURE 1

A clunking noise may occur in the drive line of some 1963-65 Corvette on initial vehicle movement in either forward or reverse gear. This could be caused by loosening of the differential carrier support bracket front attaching bolts. Loosening of these bolts will also result in elongation of the bracket bolt holes.

1. If reinforced bracket, Part No. 3868799 is not available, obtain Part No 3820186 and weld one flat washer, (Part No. 3818180) on each outside surface in line with existing holes (See Figure 1.)
