1984 - 1996 Corvette: Service Bulletin: Windshield Wipers Chatter and/or Wipe Unevenly

Subject: Windshield Wipers Chatter and/or Wipe Unevenly

Source: Chevrolet Dealer Service Bulletin

Bulletin No: 87-104

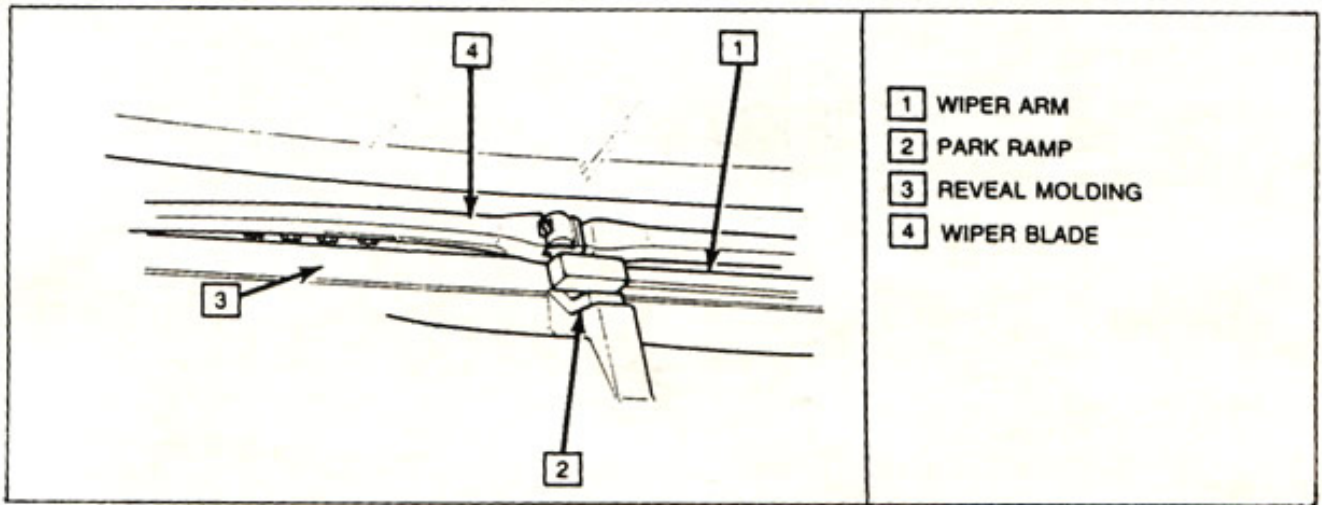
FIGURE 1

Check Fit of Windshield Reveal Molding (Figure 1)

On vehicles equipped with depressed park (hidden) wiper blades and windshield lower reveal molding, check the fit of the reveal molding across the base of the windshield. The lower reveal molding must fit uniformly along the glass surface to allow the wiper blades to move freely from the glass wiper area to the park position when the wipers are turned off. Gaps in excess of 1.0mm (.040 in.) should be corrected using the following procedure.

1. Remove both wiper arm assemblies.
2. Remove self drilling screws which retain the reveal molding.
3. Clean the underside of the lower reveal molding and the windshield glass. Remove any obstructions which prevent the reveal molding from matching the glass contour.
4. If necessary, the lower reveal molding should be reformed as required to improve the fit. Care should be used to prevent marring the molding surface.
5. Reinstall the lower reveal molding using new self-sealing screws (P/N 20564495) starting with the center screw and work outward. Use over sized screws if necessary.

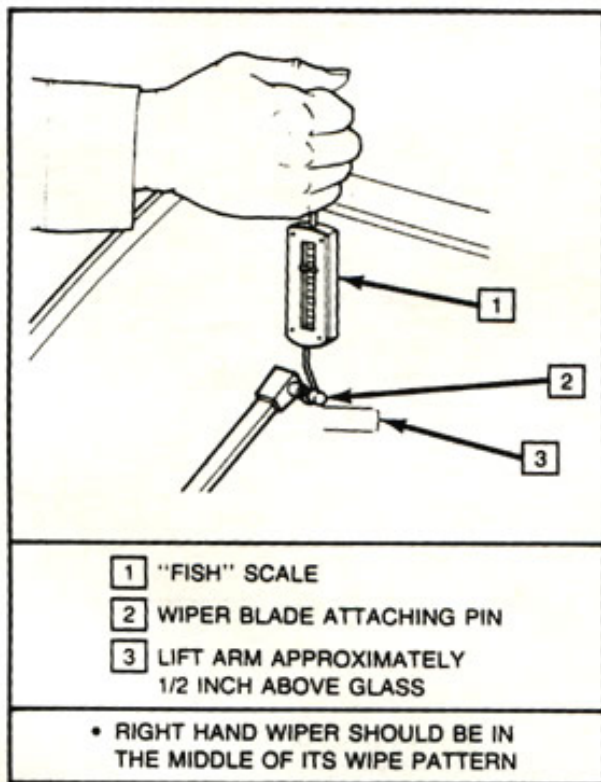
FIGURE 2

Check Windshield Wiper Arm Pressure (Figure 2)

1. Turn on ignition switch and wipers. When the right hand wiper is in the middle of a wipe stroke,, stop the wiper system by turning off the ignition switch. Proceed with the following steps to measure the right hand arm pressure. prior to measuring the left hand arm pressure be sure the left hand arm is in the middle of the wipe stroke.
2. Remove the wiper blade assembly from the wiper arm.

3. Attach a scale to the wiper arm attaching pin and measure the force required to lift the wiper arm perpendicular to the windshield to the normal working height (i.e., the height of the blade attached).
4. if the force required is not within the specifications given below, the wiper arm assembly should be replaced.

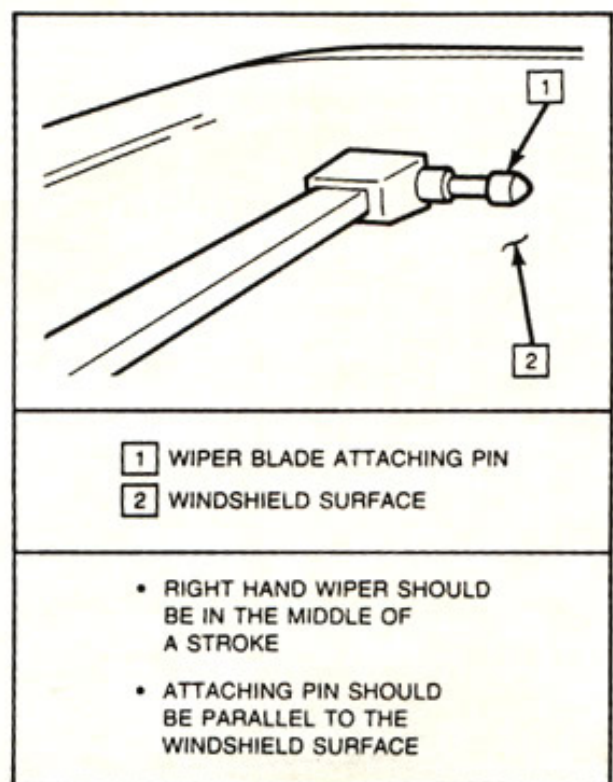
FIGURE 3

Check Wiper Blade Mounting Angle (Figure 3)

With the right hand wiper arm assembly in the middle of a wipestroke and the wiper blade assemblies removed, visually check that the blade assembly mounting pin on each wiper arm is parallel to the windshield. Replace the wiper arm if necessary.

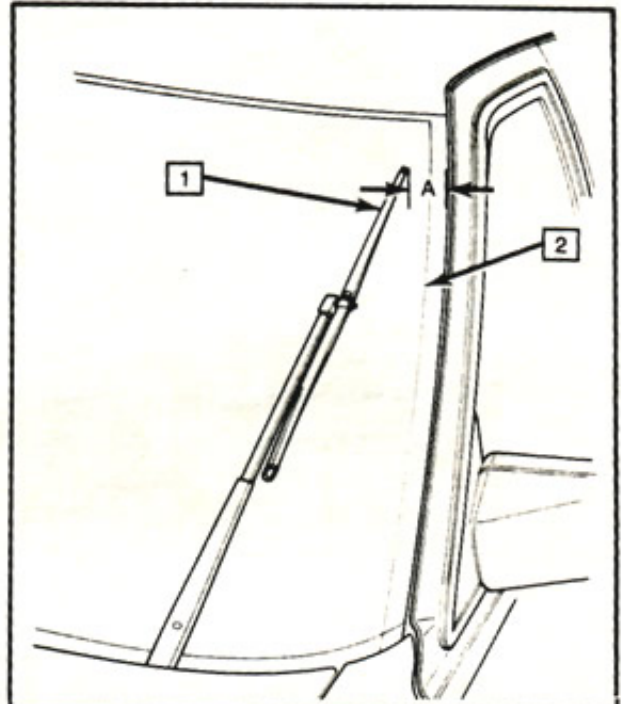
FIGURE 5

When the wipers are shut off after operation on wet glass, both wiper arm and blade assembly should be fully seated on the park ramps. In the full left stroke position, the tip of the blade element must be no more than 78mm (3 1/16 inches) from the pillar. if wipers require adjustment, refer to section 8E of the appropriate Service Manual.

• WITH LEFT HAND WIPER BLADE IN THE FULL OUTER WIPE POSITION, DIMENSION A SHOULD BE NO GREATER THAN 78mm (3-1/16 IN.)

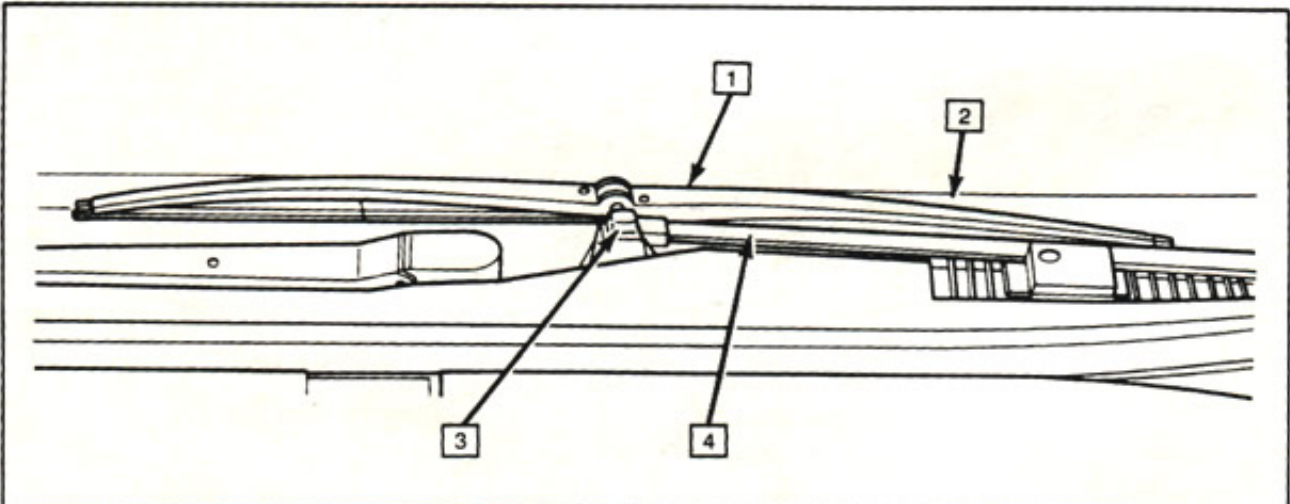
FIGURE 6

• WIPER ARM SHOULD BE FULLY SEATED ON PARK RAMP
