# 1984 - 1996 Corvette: Service Bulletin: Windshield Wipers Chatter and/or Wipe Unevenly

**Subject:** Windshield Wipers Chatter and/or Wipe Unevenly

**Source:** Chevrolet Dealer Service Bulletin

**Bulletin No:** 87-104

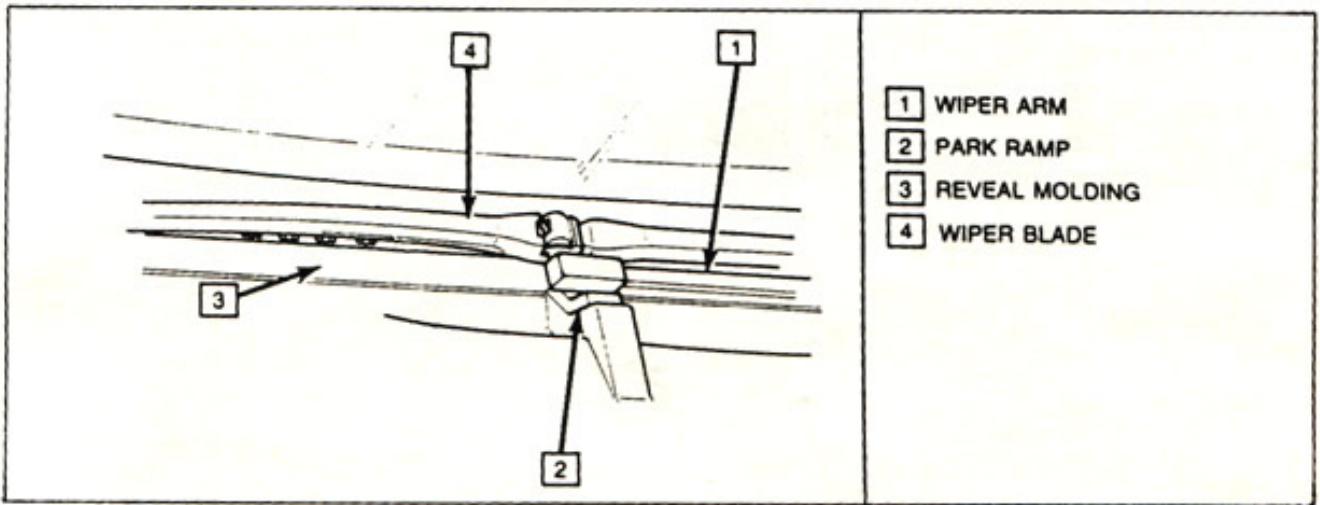
FIGURE 1

#### Check Fit of Windshield Reveal Molding (Figure 1)

On vehicles equipped with depressed park (hidden) wiper blades and windshield lower reveal molding, check the fit of the reveal molding across the base of the windshield. The lower reveal molding must fit uniformly along the glass surface to allow the wiper blades to move freely from the glass wiper area to the park position when the wipers are turned off. Gaps in excess of 1.0mm (.040 in.) should be corrected using the following procedure.

1. Remove both wiper arm assemblies.
2. Remove self drilling screws which retain the reveal molding.
3. Clean the underside of the lower reveal molding and the windshield glass. Remove any obstructions which prevent the reveal molding from matching the glass contour.
4. If necessary, the lower reveal molding should be reformed as required to improve the fit. Care should be used to prevent marring the molding surface.
5. Reinstall the lower reveal molding using new self-sealing screws (P/N 20564495) starting with the center screw and work outward. Use over sized screws if necessary.

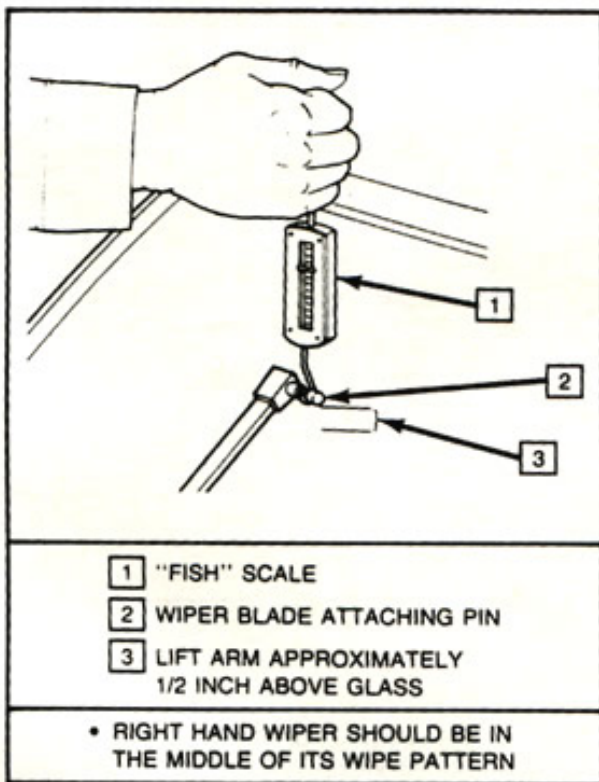
FIGURE 2

#### Check Windshield Wiper Arm Pressure (Figure 2)

3. Attach a scale to the wiper arm attaching pin and measure the force required to lift the wiper arm perpendicular to the windshield to the normal working height (i.e., the height of the blade attached).
4. if the force required is not within the specifications given below, the wiper arm assembly should be replaced.

1. Turn on ignition switch and wipers. When the right hand wiper is in the middle of a wipe stroke,, stop the wiper system by turning off the ignition switch. Proceed with the following steps to measure the right hand arm pressure. prior to measuring the left hand arm pressure be sure the left hand arm is in the middle of the wipe stroke.
2. Remove the wiper blade assembly from the wiper arm.

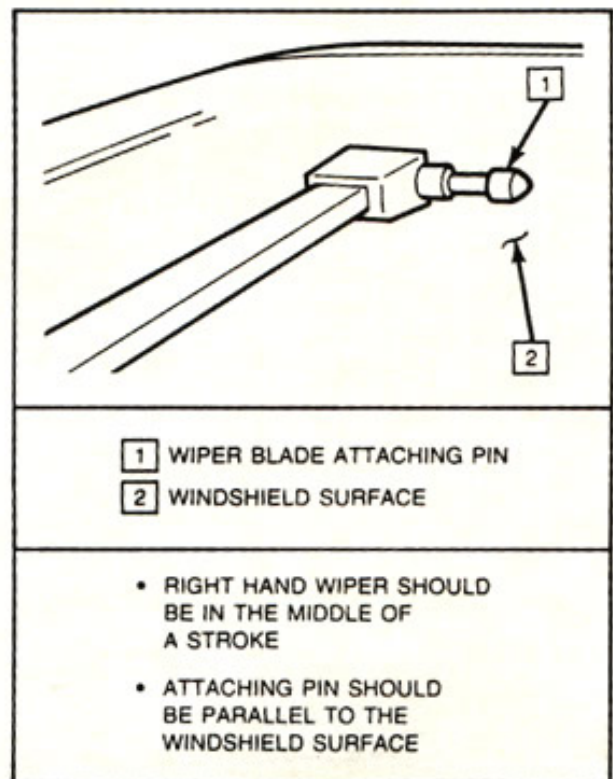
FIGURE 3

Check Wiper Blade Mounting Angle (Figure 3)

With the right hand wiper arm assembly in the middle of a wipestroke and the wiper blade assemblies removed, visually check that the blade assembly mounting pin on each wiper arm is parallel to the windshield. Replace the wiper arm if necessary.

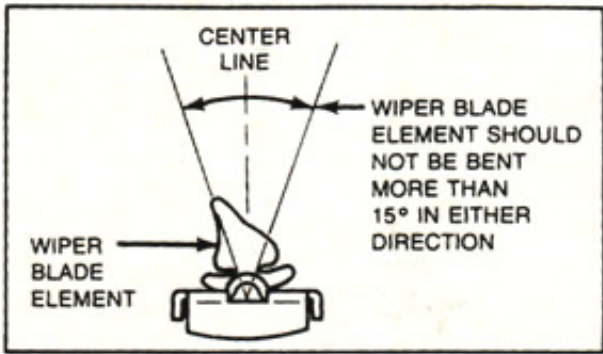
FIGURE 4

Check For Blade Set (Figure 4)

Remove the wiper blade assemblies from the wiper arms being careful to note orientation for reassembly. Look down the length of the blade element. The rubber element which contacts the glass must be on the center line of the blade assembly +/- 15 degrees. Replace the element if necessary.

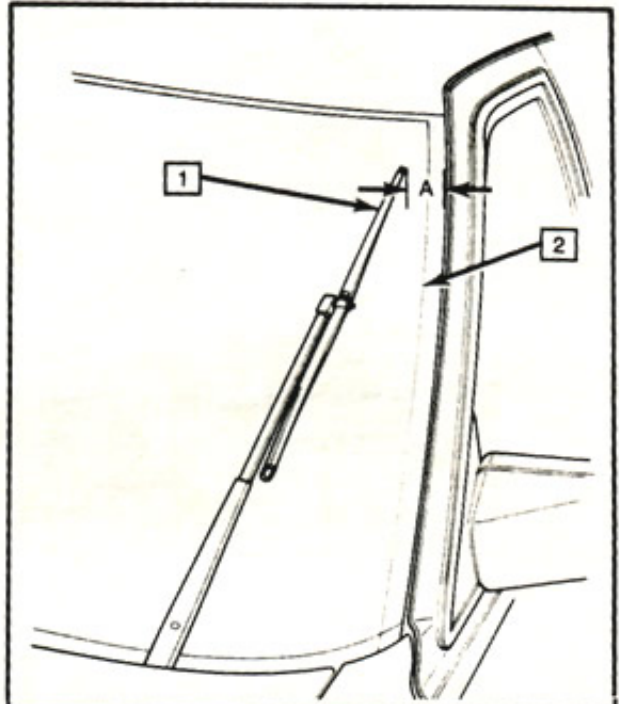
FIGURE 5

When the wipers are shut off after operation on wet glass, both wiper arm and blade assembly should be fully seated on the park ramps. In the full left stroke position, the tip of the blade element must be no more than 78mm (3 1/16 inches) from the pillar. if wipers require adjustment, refer to section 8E of the appropriate Service Manual.

• WITH LEFT HAND WIPER BLADE IN THE FULL OUTER WIPE POSITION, DIMENSION A SHOULD BE NO GREATER THAN 78mm (3-1/16 IN.)

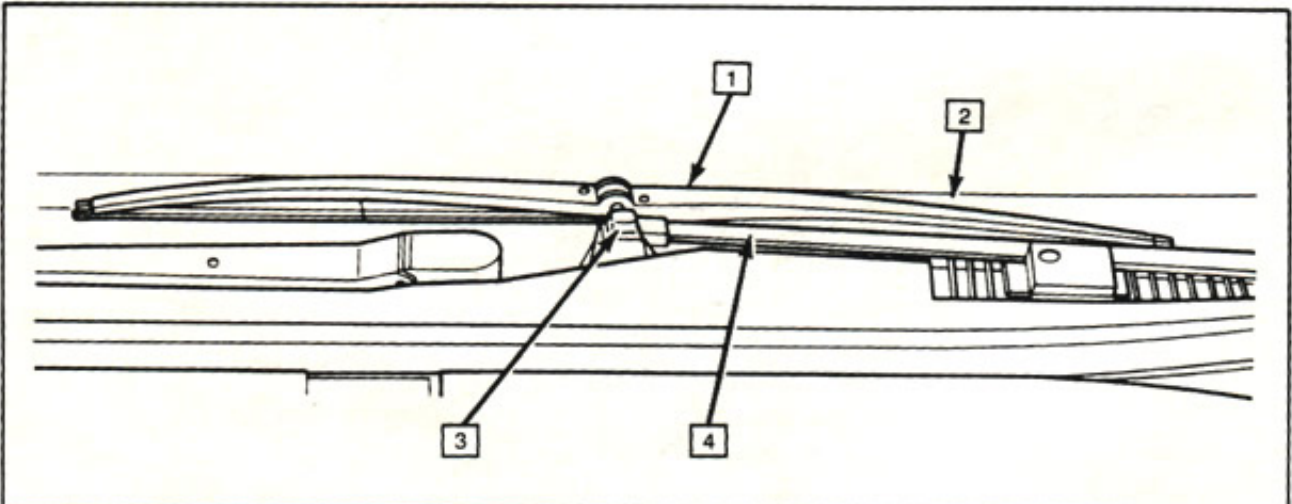
FIGURE 6

Check Wiper Arm & Park Position Adjustments (Figure 5 & 6)

• WIPER ARM SHOULD BE FULLY SEATED ON PARK RAMP
