1984 - 1996 Corvette: Service Bulletin: Windshield Wipers Chatter and/or Wipe Unevenly

Subject: Windshield Wipers Chatter and/or Wipe Unevenly **Model and Year:** Domestically Produced Passenger Cars

Source: Chevrolet Dealer Service Bulletin

Bulletin No: 87-104

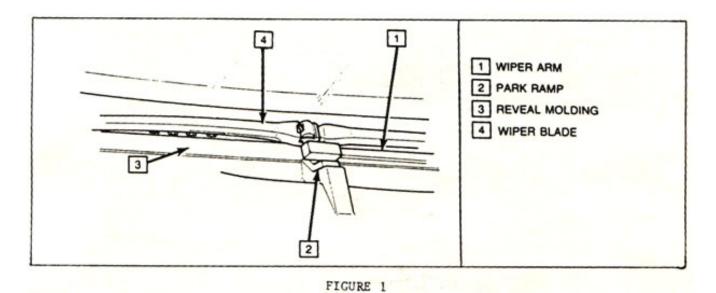
<u>Check Fit of Windshield Reveal Molding</u> (Figure 1)

On vehicles equipped with depressed park (hidden) wiper blades and windshield lower reveal molding, check the fit of the reveal molding across the base of the windshield. The lower reveal molding must fit uniformly along the glass surface to allow the wiper blades to move freely from the glass wiper area to the park position when the wipers are turned off. Gaps in excess of 1.0mm (.040 in.) should be corrected using the following procedure.

- 1. Remove both wiper arm assemblies.
- 2. Remove self drilling screws which retain the reveal molding.
- 3. Clean the underside of the lower reveal molding and the windshield glass. Remove any obstructions which prevent eh reveal molding from matching the glass contour.
- 4. If necessary, the lower reveal molding should be reformed as required to improve the fit. Care should be used to prevent marring the molding surface.
- 5. Reinstall the lower reveal molding using new self-sealing screws (P/N 20564495) starting with the center screw and work outward. Use over sized screws if necessary.

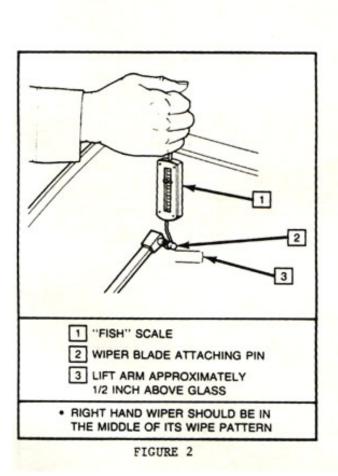
<u>Check Windshield Wiper Arm Pressure</u> (Figure 2)

- 1. Turn on ignition switch and wipers. When the right hand wiper is in the middle of a wipe stroke,, stop the wiper system by turning off the ignition switch. Proceed with the following steps to measure the right hand arm pressure. prior to measuring the left hand arm pressure be sure the left hand arm is in the middle of the wipe stroke.
- 2. Remove the wiper blade assembly from the wiper arm.

- 3. Attach a scale to the wiper arm attaching pin and measure the force required to lift the wiper arm perpendicular to the windshield to the normal working height (i.e., the height of the blade attached).
- 4. if the force required is not within the specifications given below, the wiper arm assembly should be replaced.

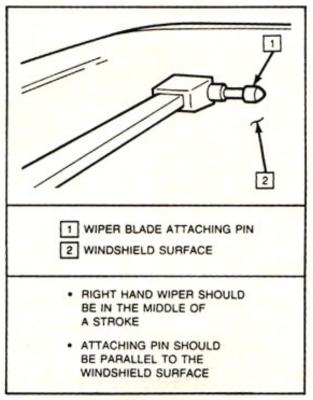
FIGURE 3

<u>Check Wiper Blade Mounting Angle</u> (Figure 3)

With the right hand wiper arm assembly in the middle of a wipestroke and the wiper blade assemblies removed, visually check that the blade assembly mounting pin on each wiper arm is parallel to the windshield. Replace the wiper arm if necessary.

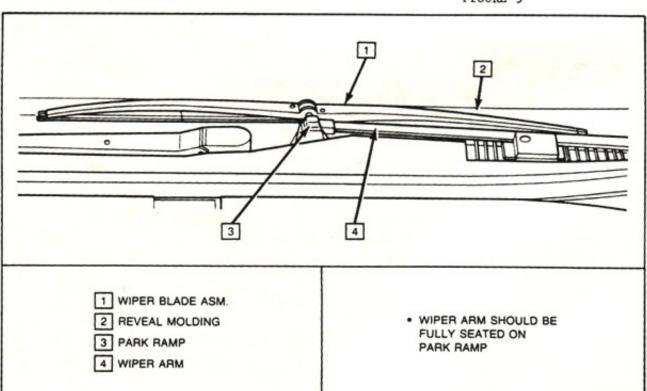
FIGURE 6

<u>Check Wiper Arm & Park Position Adjustments</u> (Figure 5 & 6)

When the wipers are shut off after operation on wet glass, both wiper arm and blade assembly should be fully seated on the park ramps. In the full left stroke position, the tip of the blade element must be no more than 78mm (3 1/16 inches) from the pillar. if wipers require adjustment, refer to section 8E of the appropriate Service Manual.
