1968 Corvette: Inter-Organization Letter: Water Leaks - 1968 Corvette Aero-Coupe and Convertible Supplement to A.I. 68-11

CHEVROLET MOTOR DIVISION General Motors Corporation

WATER LEAKS - 1968 CONVETTE AERO COUPE AND CONVERTIBLE SUPPLEMENT TO A.I. 68-11

Date October 16, 1968

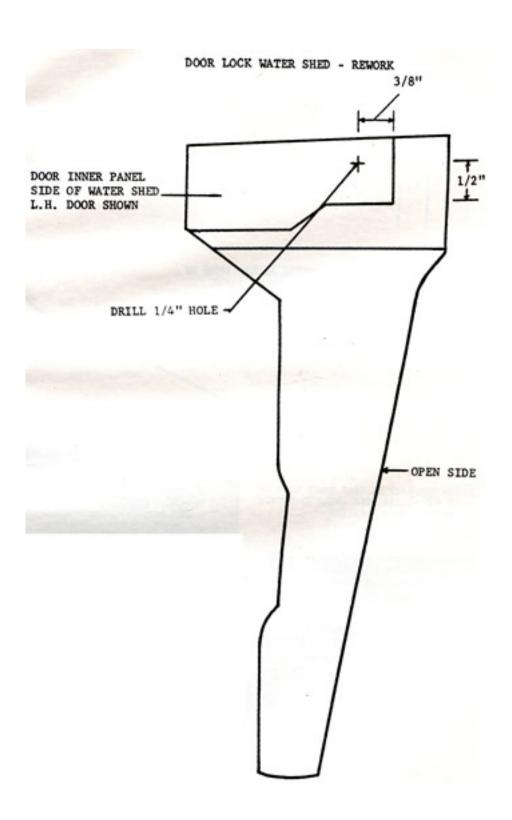
L. H. DOOR SHOWN - REVERSE FOR R. H. DOOR

Some of the late style water sheds were manufactured with the inner attaching hole not drilled. This hole may be located by using the sketch on Page 3, of this supplement
