1968 Corvette: Inter-Organization Letter: Water Leaks - 1968 Corvette Aero-Coupe and Convertible Supplement to A.I. 68-11

CHEVROLET MOTOR DIVISION General Motors Corporation

WATER LEAKS - 1968 CONVETTE AERO COUPE AND CONVERTIBLE SUPPLEMENT TO A.I. 68-11

Date October 16, 1968

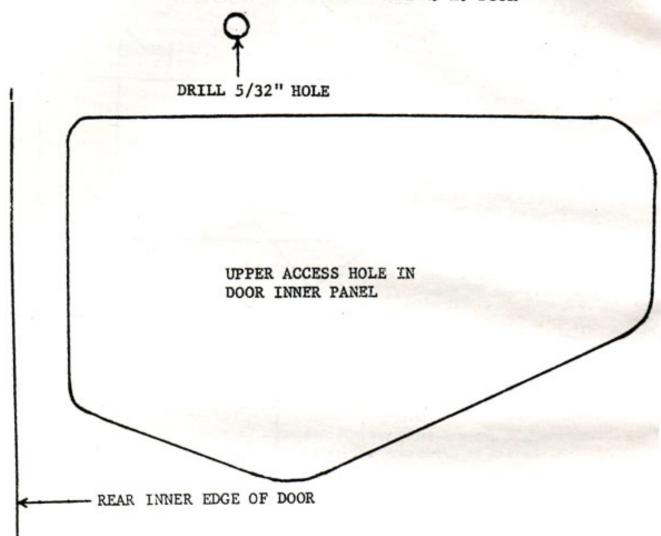
This late style water shed should be installed using the template attached to this supplement on Pages 4 and 5.

ALIGN TEMPLATE TO REAR INNER EDGE OF DOOR AND ACCESS HOLE EDGES TO LOCATE WATER SHED HOLE LOCATION

L. H. DOOR SHOWN - REVERSE FOR R. H. DOOR

DRILL 5/32" HOLE ---

ALIGN TEMPLATE TO (3) DOOR LOCK ATTACHING SCREWS TO LOCATE HOLE FOR WATER SHED INSTALLATION
