1973 - 1974 Corvette: Service Bulletin: Engine Overheat Due to Blocked Coolant Passage in the Cylinder Head

Source: Chevrolet Dealer Service Technical Bulletin

Bulletin No: 74-T-6

Date: Dec. 5, 1973

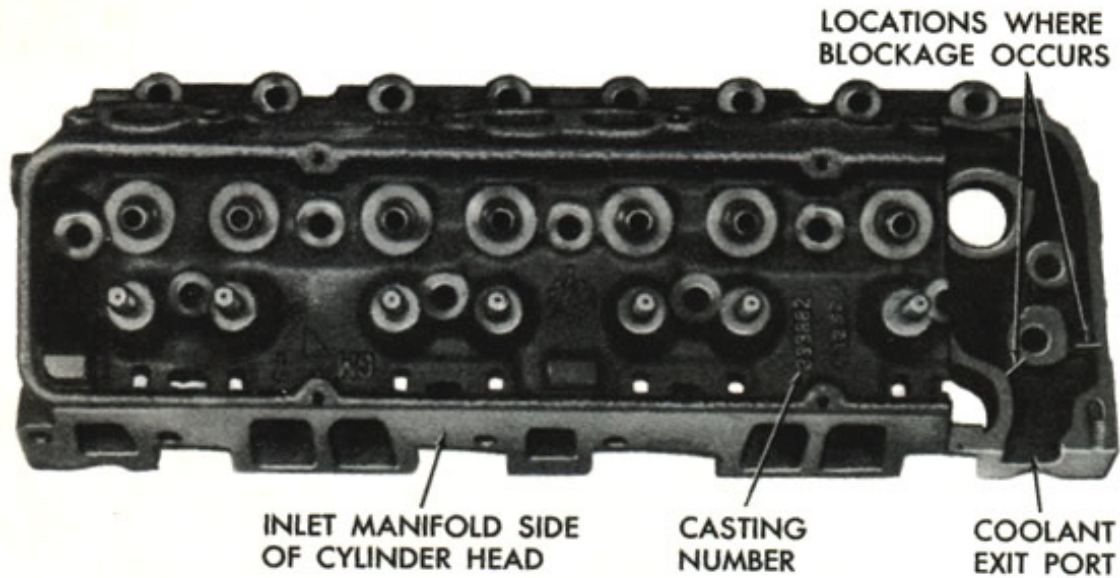
A small number of 350 and 400 cubic inch displacement V-8 engines were built before 9/24/73 (0924) with a coolant blockage in the cylinder head resulting in an overheat condition. A 1974 casting process change has resulted in a possible blockage of the coolant exit port in cylinder head casting No. 333882 (casting number appears on the top of the cylinder head beneath the rocker cover). This cylinder head is common to all 1974 small block V-8 engines, except for those used in C-K30 and 50 thru 60 series trucks.

6. If a blockage is present, it will occur at a depth of approximately five and one half (5-1/2) to six (6) inches from the edge of the thermostat port.

TOP VIEW OF A CYLINDER HEAD PARTIALLY SECTIONED TO SHOW BLOCKED COOLANT PASSAGES

7. The blocked coolant port can be repaired by removing the inlet manifold and knocking out the casting flash in the blocked water passage with a suitable tool. Take care not to damage the oil drain boss. The particles of flashing that fall into the water jacket do not have to be removed. If the blockage cannot be removed, the cylinder head should be replaced.

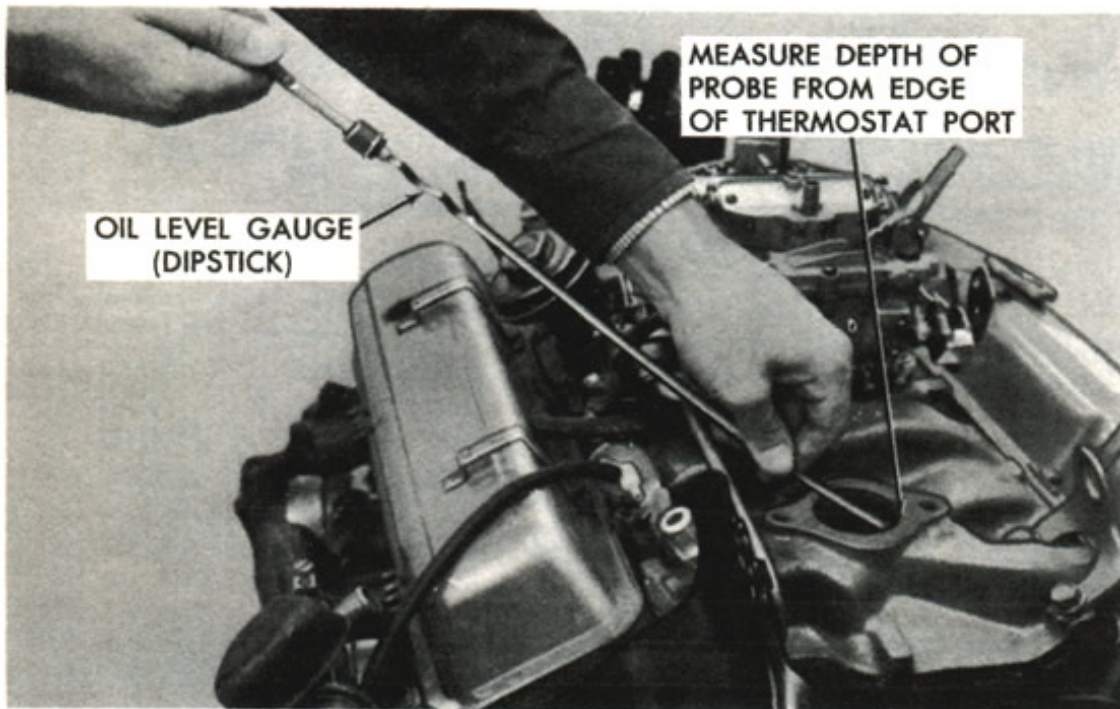
1. Remove the thermostat housing and thermostat.
2. Insert the oil level gauge (dipstick) into the thermostat port thru the inlet manifold coolant passage and into the cylinder head (refer to the illustration on page 3).

3. Work the dipstick into the cylinder head as far as possible by carefully rotating and pushing the handle with one hand while guiding the blade with the other hand.

4. If at least seven (7) inches of the dipstick is inserted past the edge of the thermostat port, there is no blockage.
5. Remove the dipstick and repeat the test for the other cylinder head.

INSPECTION PROBE OF COOLANT EXIT PORT
