# 1973 - 1974 Corvette: Service Bulletin: Engine Overheat Due to Blocked Coolant Passage in the Cylinder Head

**Source:** Chevrolet Dealer Service Technical Bulletin

**Bulletin No:** 74-T-6

**Date:** Dec. 5, 1973

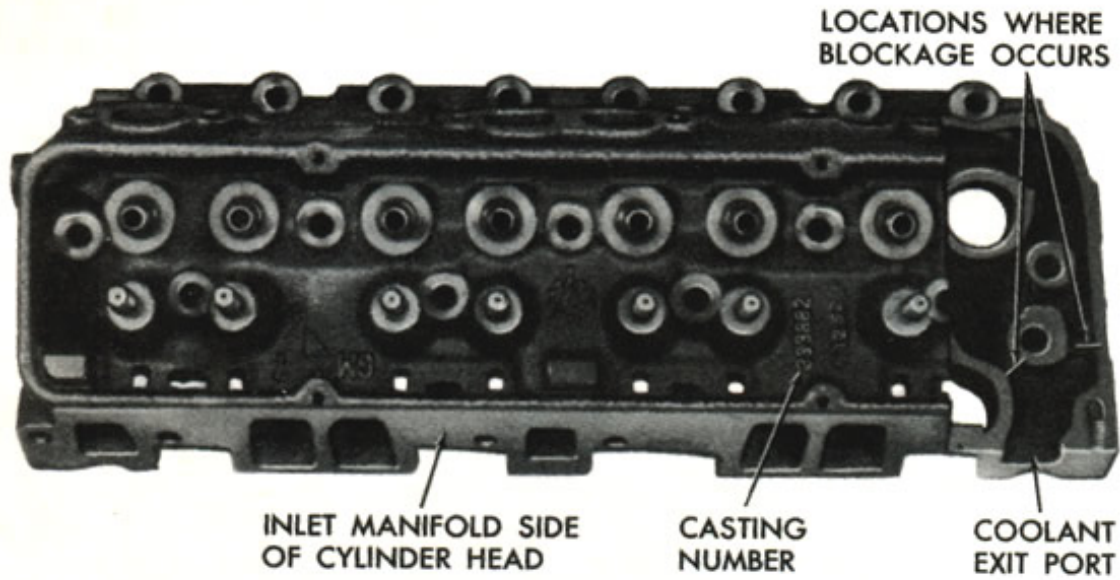
A small number of 350 and 400 cubic inch displacement V-8 engines were built before 9/24/73 (0924) with a coolant blockage in the cylinder head resulting in an overheat condition. A 1974 casting process change has resulted in a possible blockage of the coolant exit port in cylinder head casting No. 333882 (casting number appears on the top of the cylinder head beneath the rocker cover). This cylinder head is common to all 1974 small block V-8 engines, except for those used in C-K30 and 50 thru 60 series trucks.

6. If a blockage is present, it will occur at a depth of approximately five and one half (5-1/2) to six (6) inches from the edge of the thermostat port.

**TOP VIEW OF A CYLINDER HEAD PARTIALLY SECTIONED TO SHOW BLOCKED COOLANT PASSAGES**

7. The blocked coolant port can be repaired by removing the inlet manifold and knocking out the casting flash in the blocked water passage with a suitable tool. Take care not to damage the oil drain boss. The particles of flashing that fall into the water jacket do not have to be removed. If the blockage cannot be removed, the cylinder head should be replaced.
