1984 Corvette: Recall: Product Safety Campaign 84C25 Rear Axle Differential Cross Shaft

Subject: Product Safety Campaign 84C25 Rear Axle Differential Cross Shaft

Model and Year: 1984 Chevrolet Corvette Models

Bulletin No: 84C25

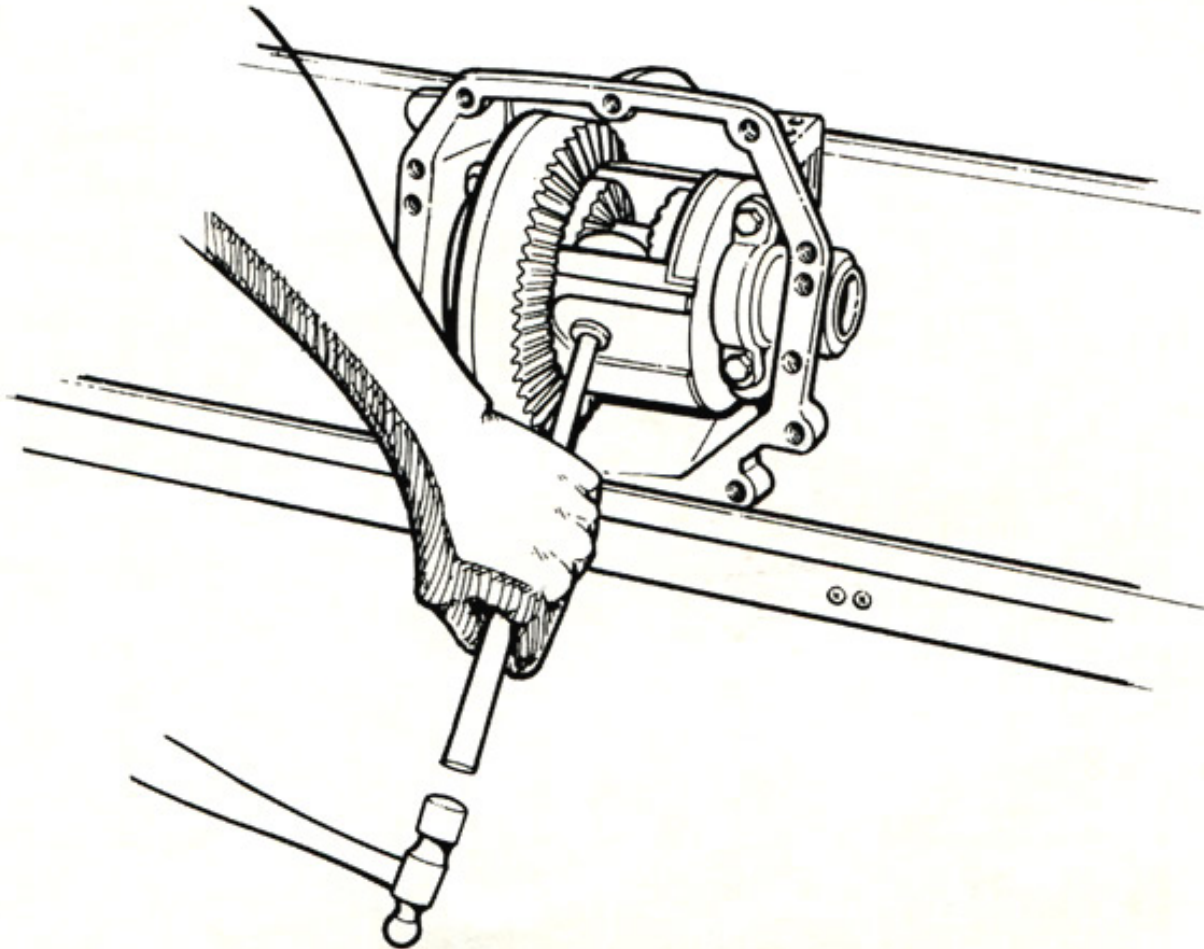
FIGURE 1

5. Rotate case assembly to position illustrated in Figure 1. With appropriate size drift and small mallet, lightly tap on cross shaft to determine if movement of shaft can be achieved.

Tap cross shaft inboard approximately $1\frac{1}{4}$ inches and rotate case 180°. Utilizing vise grips and a back and forth motion, remove shaft. Install new cross shaft insuring detents in the shaft are positioned properly to accept spheres (balls) to be installed between shaft and output yokes as illustrated in Figure 2.
