1967 - 1975 Corvette: Service Bulletin: Fabric Roof Cover Repairs

Subject: Fabric Roof Cover Repairs

Source: Chevrolet Dealer Service Information Bulletin

Bulletin No: 69-I-2 (Supplement)

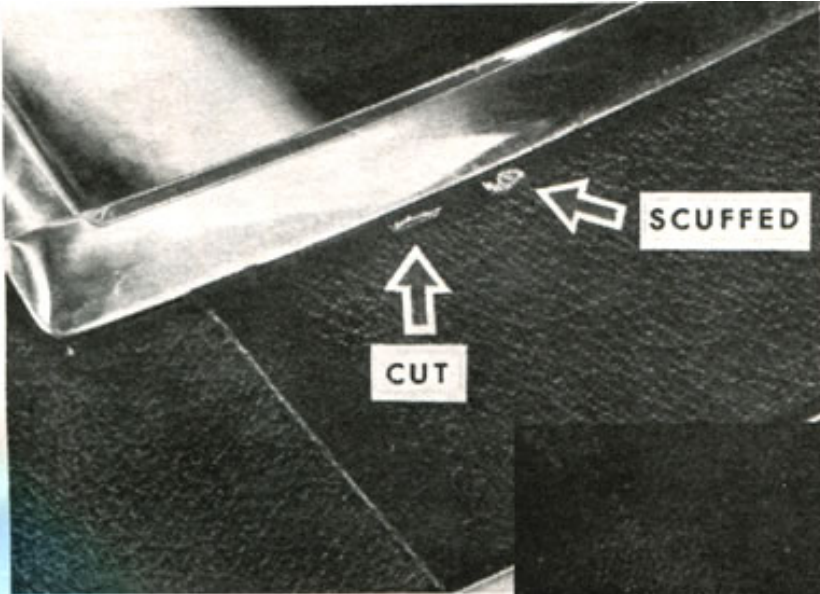
TYPICAL FABRIC
ROOF COVER DIS-
CREPANCIES
FIGURE 1

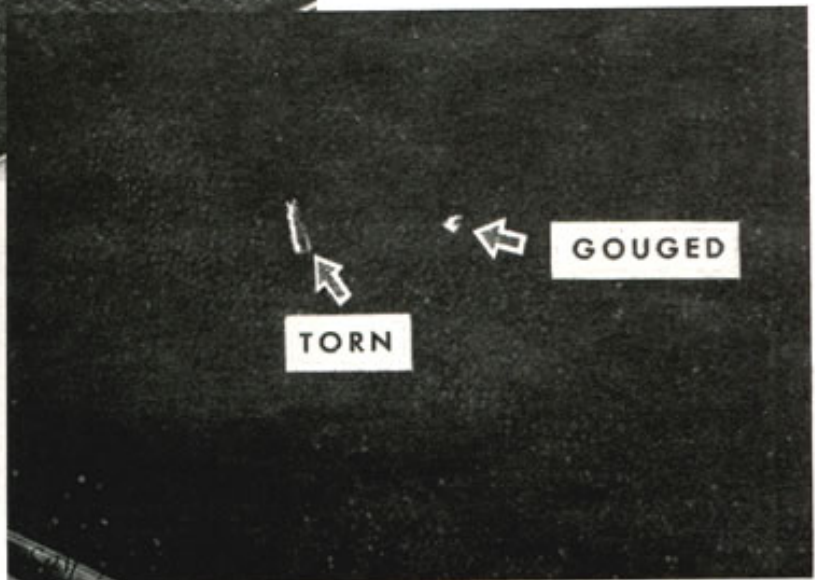
TYPICAL FABRIC ROOF
COVER DISCREPANCIES
FIGURE 2
