1959 - 1960 Corvette: Service Bulletin: Front and Rear Door Glass Loose in Run Channels

Source: Chevrolet Technical Service Bulletin

Bulletin No: DR #651

Date: April 7, 1960

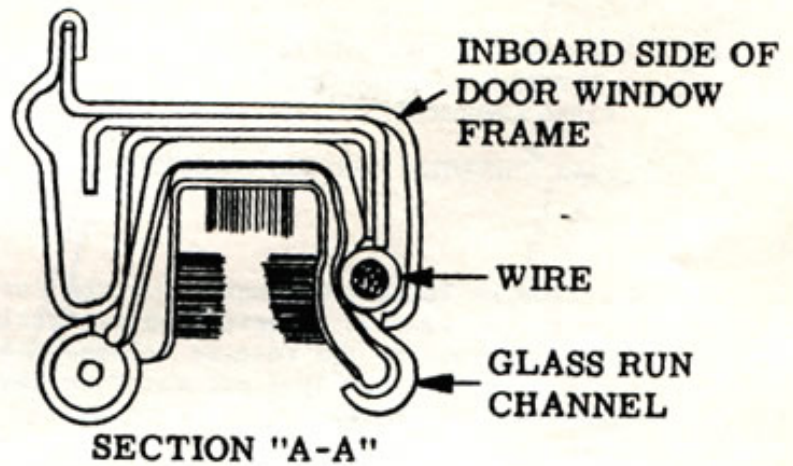
FIGURE #1

If front or rear door window glasses are excessively loose in the glass run channels, causing rattles or air leaks, the condition may be corrected as follows:

"IN AND OUT" LOOSENESS

The condition of "in and out" looseness may be corrected by installing black insulated wire or similar material between the glass run channel and the inboard side of door window frame as shown in Section "A-A", figure #1. Wire should be approximately 15" long. Insert wire from belt line to top of window frame. Trim off excess wire as required.

The degree of "in and out" movement of the door window will determine the gauge of wire necessary to correct this discrepancy; however, a #14 gauge wire will normally correct the condition. On doors where the "in and out" movement of the window is very small, #20 gauge wire may be adequate.

If glass is still loose, a second piece of wire may be inserted between the channel and outboard side of window frame.

On front doors, the repair may be performed along the door lock pillar section only. However, on rear doors, the repair may be performed along either lock pillar or hinge pillar sections, or both, depending upon severity of condition.
