1959 - 1960 Corvette: Service Bulletin: Front and Rear Door Glass Loose in Run Channels

Source: Chevrolet Technical Service Bulletin

Bulletin No: DR #651

Date: April 7, 1960

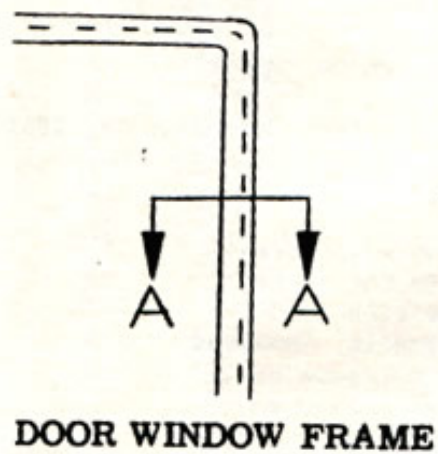
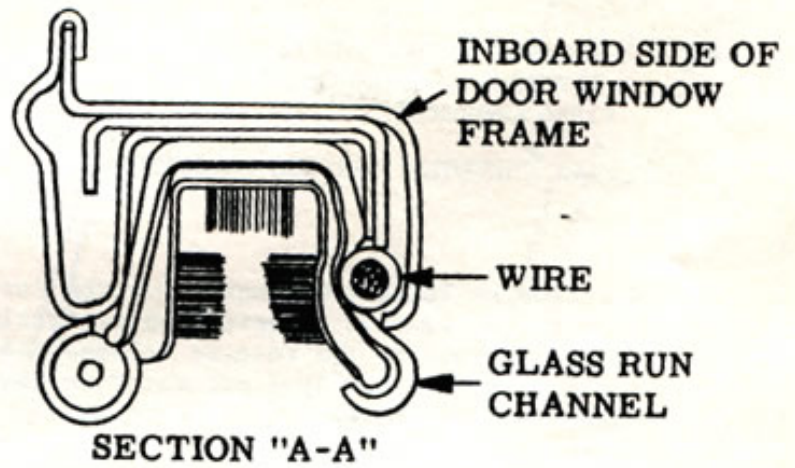
FIGURE #1

If front or rear door window glasses are excessively loose in the glass run channels, causing rattles or air leaks, the condition may be corrected as follows:

The condition of "in and out" looseness may be corrected by installing black insulated wire or similar material between the glass run channel and the inboard side of door window frame as shown in Section "A-A", figure #1. Wire should be approximately 15" long. Insert wire from belt line to top of window frame. Trim off excess wire as required.

The degree of "in and out" movement of the door window will determine the gauge of wire necessary to correct this discrepancy; however, a #14 gauge wire will normally correct the condition. On doors where the "in and out" movement of the window is very small, #20 gauge wire may be adequate.

If glass is still loose, a second piece of wire may be inserted between the channel and outboard side of window frame.

On front doors, the repair may be performed along the door lock pillar section only. However, on rear doors, the repair may be performed along either lock pillar or hinge pillar sections, or both, depending upon severity of condition.
