# 2015 Corvette: GM TechLink: Infotainment Display Screen Conditions

**Subject:** Infotainment Display Screen Conditions

**Source:** GM TechLink

**Date:** February 5, 2015

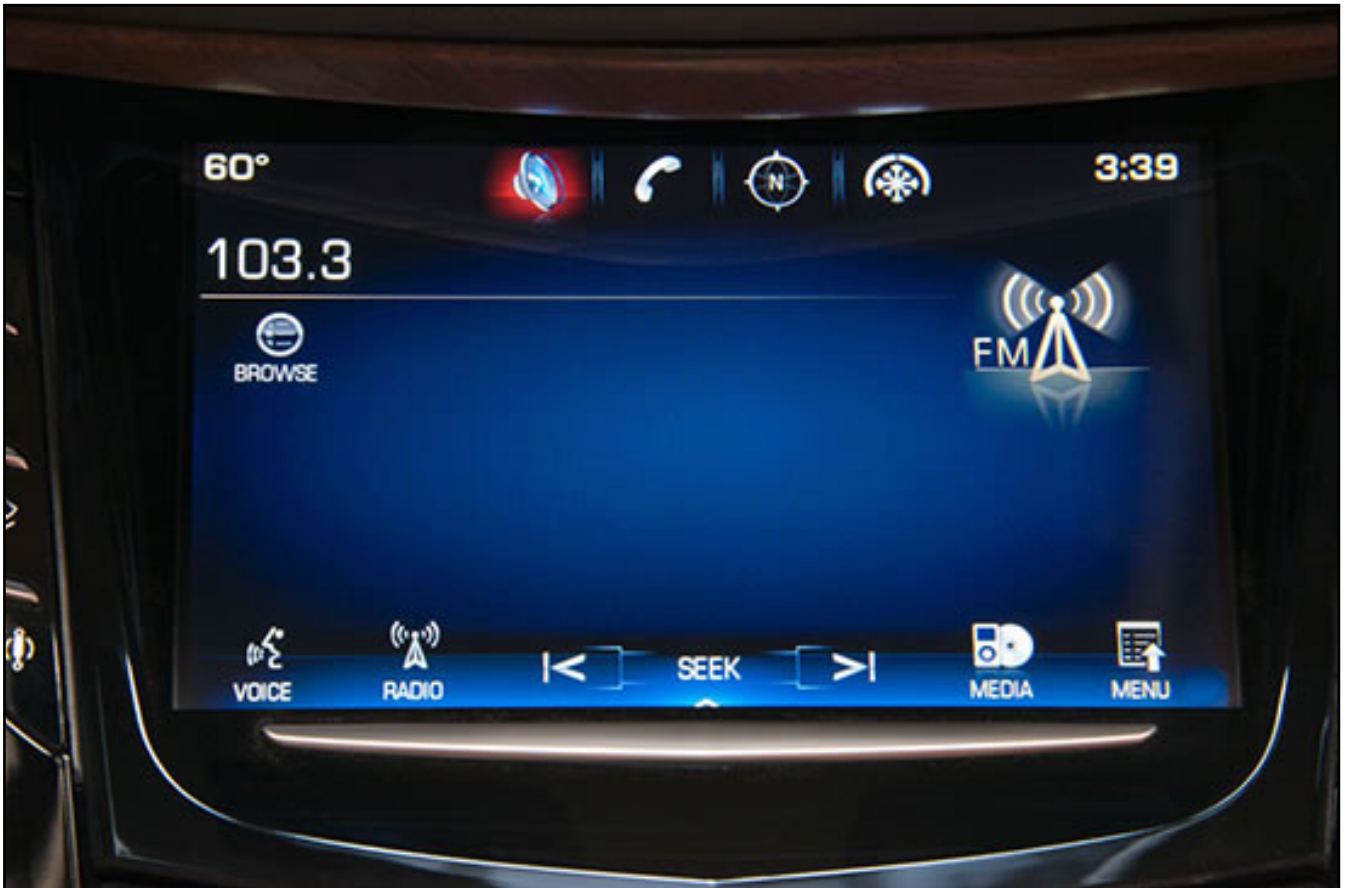
**Fig. 8**

On some 2015 LaCrosse, Regal, ATS, CTS Sedan (VIN A), Escalade models (with RPO AVF), SRX, XTS, Colorado, Corvette, Impala (VIN 1), Silverado, Suburban (with RPO AVF), Tahoe (with RPO AVF), Canyon, Sierra, and Yukon models (with RPO AVF) equipped with RPOs RAO (SRX Only), RAO + UA3/UY4, IO4, IO5, or IO6, there may be multiple infotainment display screen conditions. (Fig. 8) These conditions may include a blank display, the display screen stuck in incoming call view after a phone call, and a blank Rear View Camera display. In addition, other possible conditions include unavailable navigation screen audio content, USB issues, inoperative speech recognition, traffic messages and clock display issues.

An updated software calibration has been released to address these conditions. Update the Human Machine Interface (HMI) Module using a USB flash drive and the Service Programming System (SPS) with the files available on TIS2Web.

The USB flash drive programming event is not a standard TIS2Web programming event. Use TIS2Web to download the updated version of the software for the vehicle that is being programmed to minimize the chance of flashing the wrong software into the HMI module.

After USB programming has been completed, reprogram the HMI module using SPS with the latest calibrations available on TIS2Web.

The vehicle modules must go to sleep for five minutes after programming the HMI module. If not, the vehicle may have a blank screen, no audio, no touch response, or the wrong splash screen may appear on the screen. If this happens, turn off the vehicle and wait the required five minutes before starting vehicle again.
