# 2014 Corvette: GM TechLink: Techline Infotainment DVD Software Update

**Subject:** Techline Infotainment DVD Software Update

**Source:** GM TechLink

**Date:** February 5, 2015

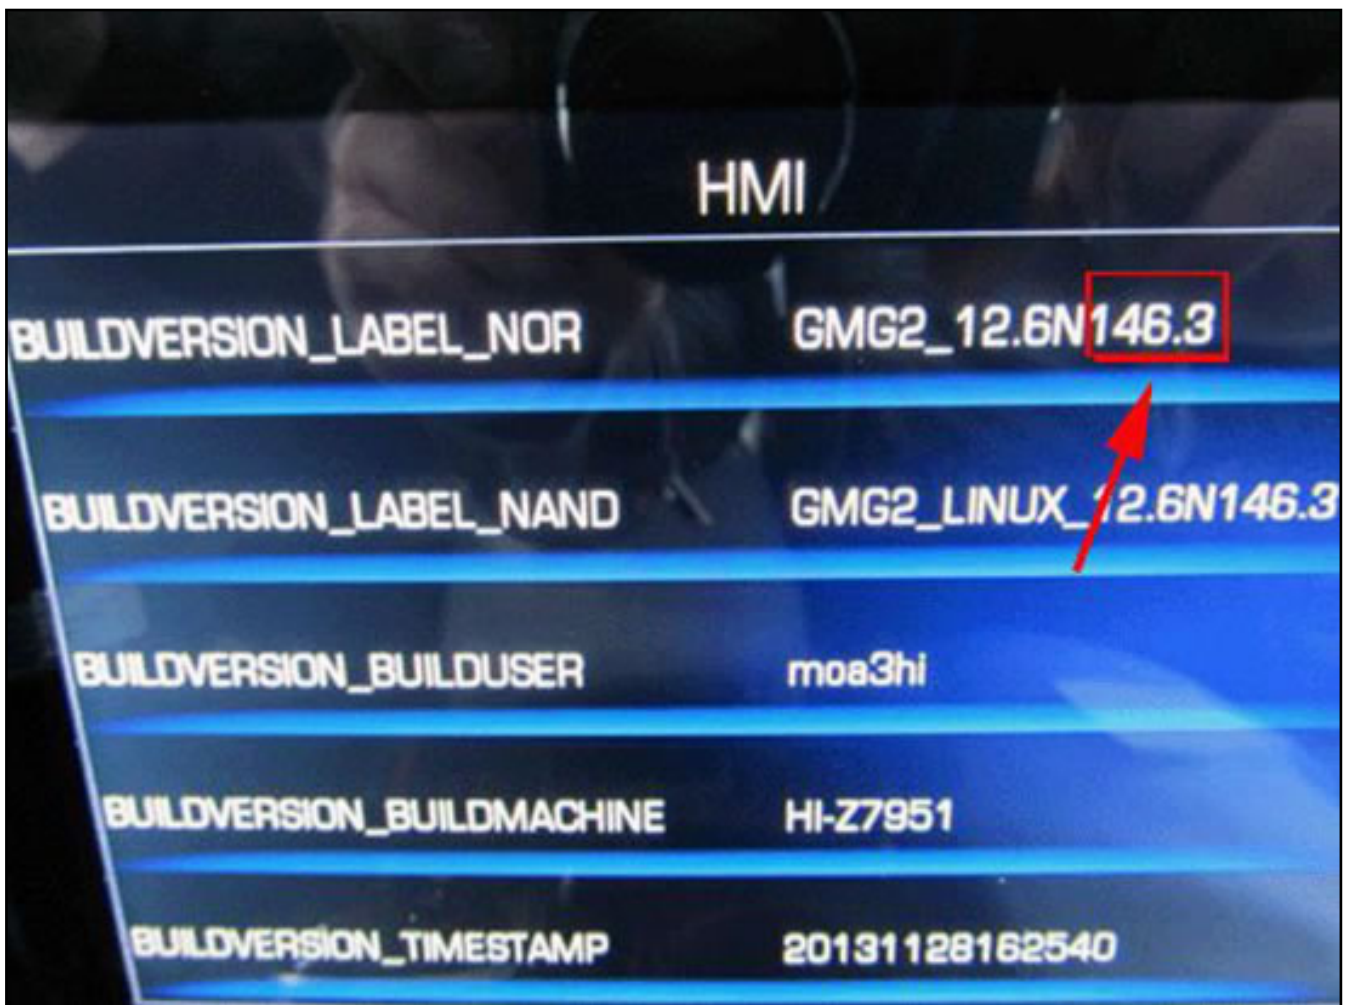
**Fig. 9**

Before updating the infotainment system software, check the Human Machine Interface (HMI) build version. The HMI build version label should be GMG2.12.6N146.4 or lower. (Fig. 9)

If the software version is higher than GMG2.12.6N146.4, damage to the HMI module may occur. Do not update the infotainment system software if the software version is higher than GMG2.12.6N146.4.

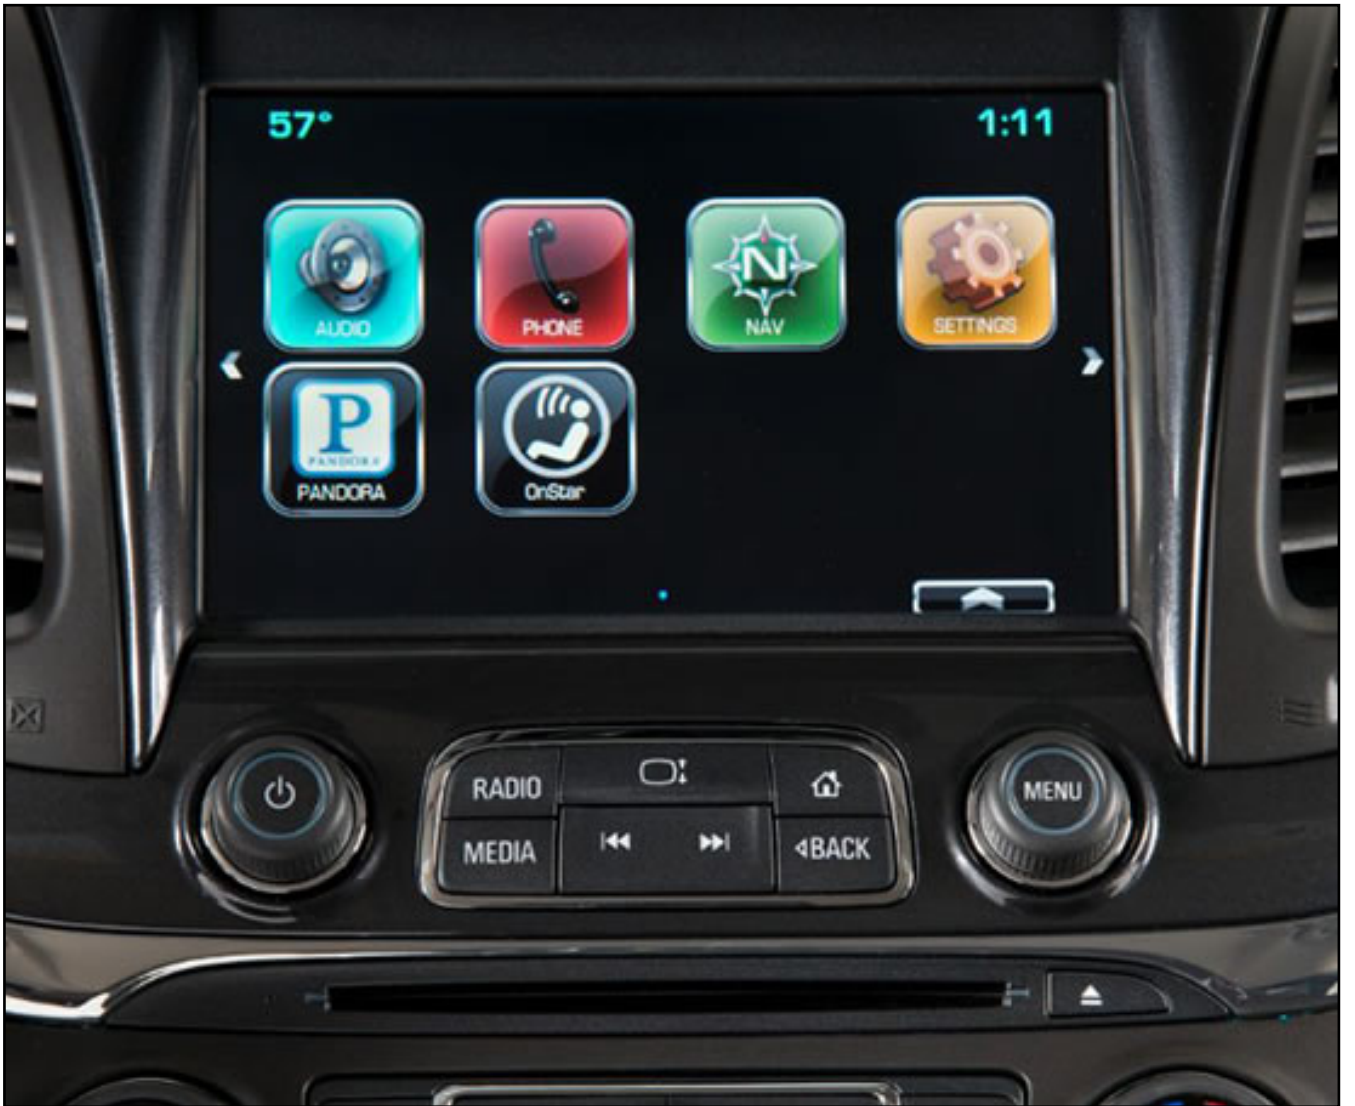
**Fig. 10**

To verify the HMI build version on Buick, Chevrolet and GMC models, press the Power, Menu and Home buttons at the same time on the infotainment system, and then select HMI from the onboard development screen. (Fig. 10)
