# 1988 - 1989 Corvette: Recall Notice: Rear Wheel Tie Rod

**Bulletin No:** 89C17

Subject: PRODUCT SAFETY CAMPAIGN 89C17  
REAR WHEEL TIE ROD

Model and Year: 1988-89 CHEVROLET CORVETTE

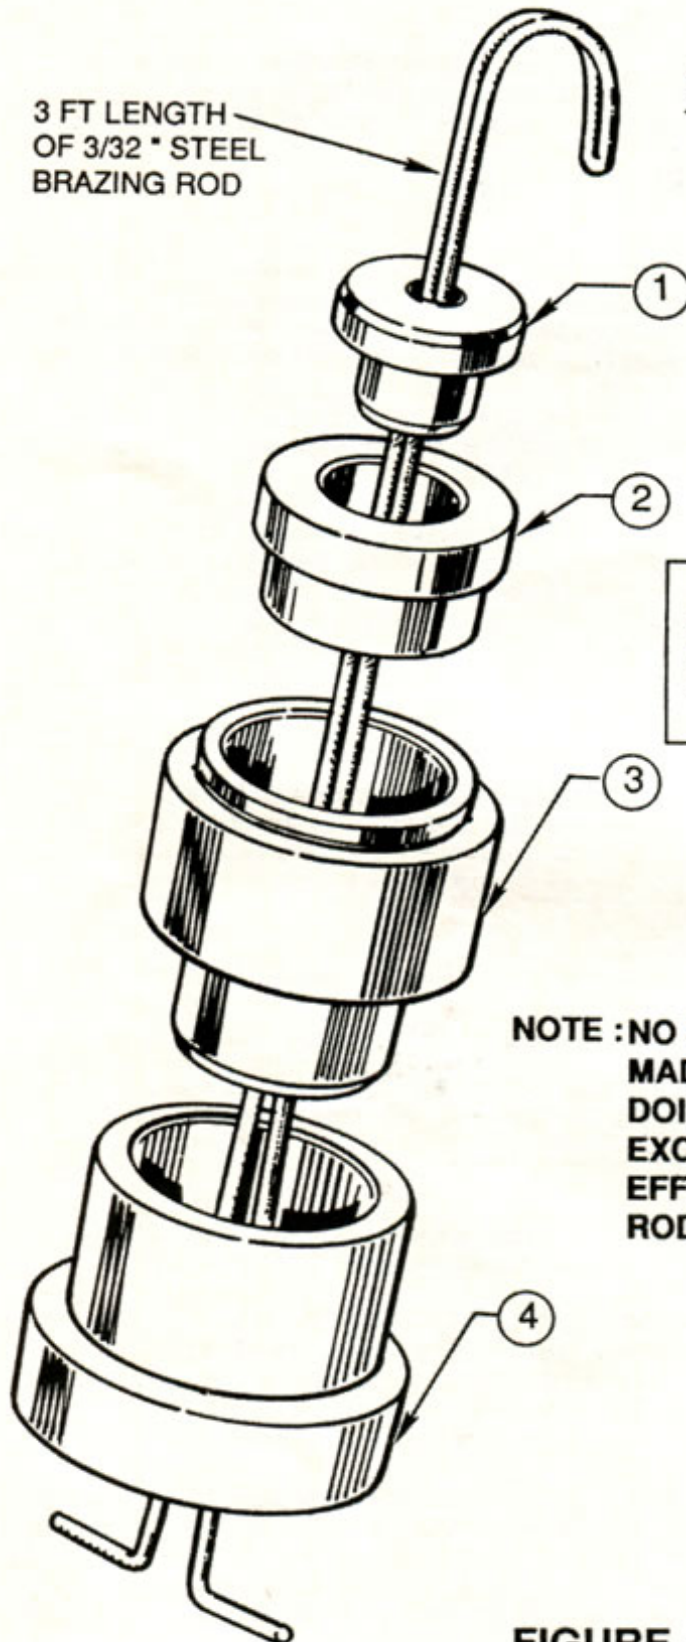
**FIGURE 1**

**NOTE : NO SUBSTITUTIONS SHOULD BE  
MADE FOR THE TOOLS INDICATED.  
DOING SO, MAY RESULT IN AN  
EXCESSIVE WEIGHT WHICH COULD  
EFFECT THE ACCURACY OF TIE  
ROD INSPECTION.**

1. Fabricate/Assemble weight from materials indicated and as illustrated in Figure 1.
2. Raise Vehicle.
3. Remove cotter pins, nuts and washers from both outer rear tie rod ends and disconnect from knuckle assemblies utilizing tool J-24319-01.
