1959 Corvette: Service Bulletin: Windshield Washers

SUBJECT: 1959 PASSENGER CAR
WINDSHIELD WASHERS

BULLETIN No. DR #405

March 18, 1959

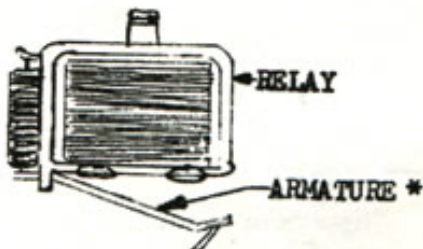
FIG. #3

ARMATURE - EARLY DESIGN

RELAY & ARMATURE WITH
TERMINAL BOARD REMOVED
(FOR ILLUSTRATION)

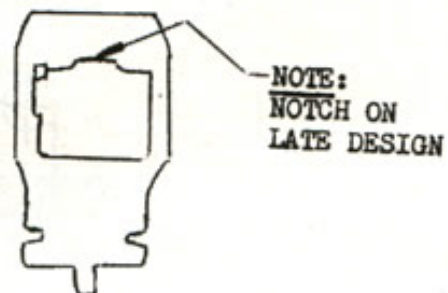
ARMATURE - LATE DESIGN
FIG. #4

A few very early units may have a relay armature with a small opening or window which may contact the drive pawl. This could allow the drive pawl to push the armature up out of the park position and allow unit to recycle. Later armatures had a wider window and also a notch at end that contacts nylon gear. This notch prevented the drive pawl from catching top of ratchet tooth which also may cause unit to recycle. Later armatures incorporated additional features to maintain free movement and assume proper stop.

CORRECTION: Replace Relay and Terminal Board Assembly, #4906055 (late type armature is part of this assembly).

NOTE: See Figure #4, examples of early and late armature.
