1959 Corvette: Service Bulletin: Windshield Washers

SUBJECT: 1959 PASSENGER CAR
WINDSHIELD WASHERS

BULLETIN No. DR #405

March 18, 1959

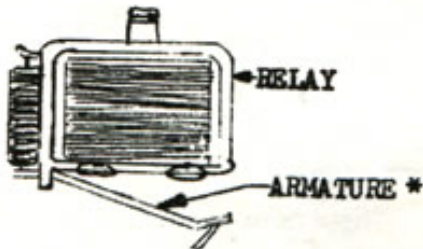
FIG. #3

RELAY & ARMATURE WITH
TERMINAL BOARD REMOVED
(FOR ILLUSTRATION)

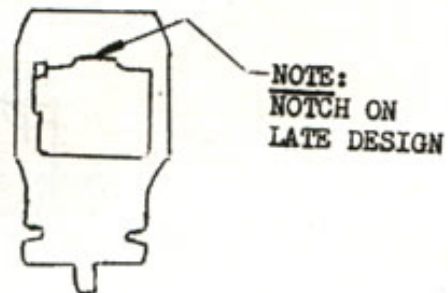
ARMATURE - LATE DESIGN
FIG. #4

A few very early units may have a relay armature with a small opening or window which may contact the drive pawl. This could allow the drive pawl to push the armature up out of the park position and allow unit to recycle. Later armatures had a wider window and also a notch at end that contacts nylon gear. This notch prevented the drive pawl from catching top of ratchet tooth which also may cause unit to recycle. Later armatures incorporated additional features to maintain free movement and assume proper stop.

CORRECTION: Replace Relay and Terminal Board Assembly, #4906055 (late type armature is part of this assembly).

NOTE: See Figure #4, examples of early and late armature.
