1964 Corvette: Service Bulletin: 4-Speed Shift Lever Revision

Source: Chevrolet Technical Service Bulletin

Bulletin No: DR #691

Date: September 8, 1964

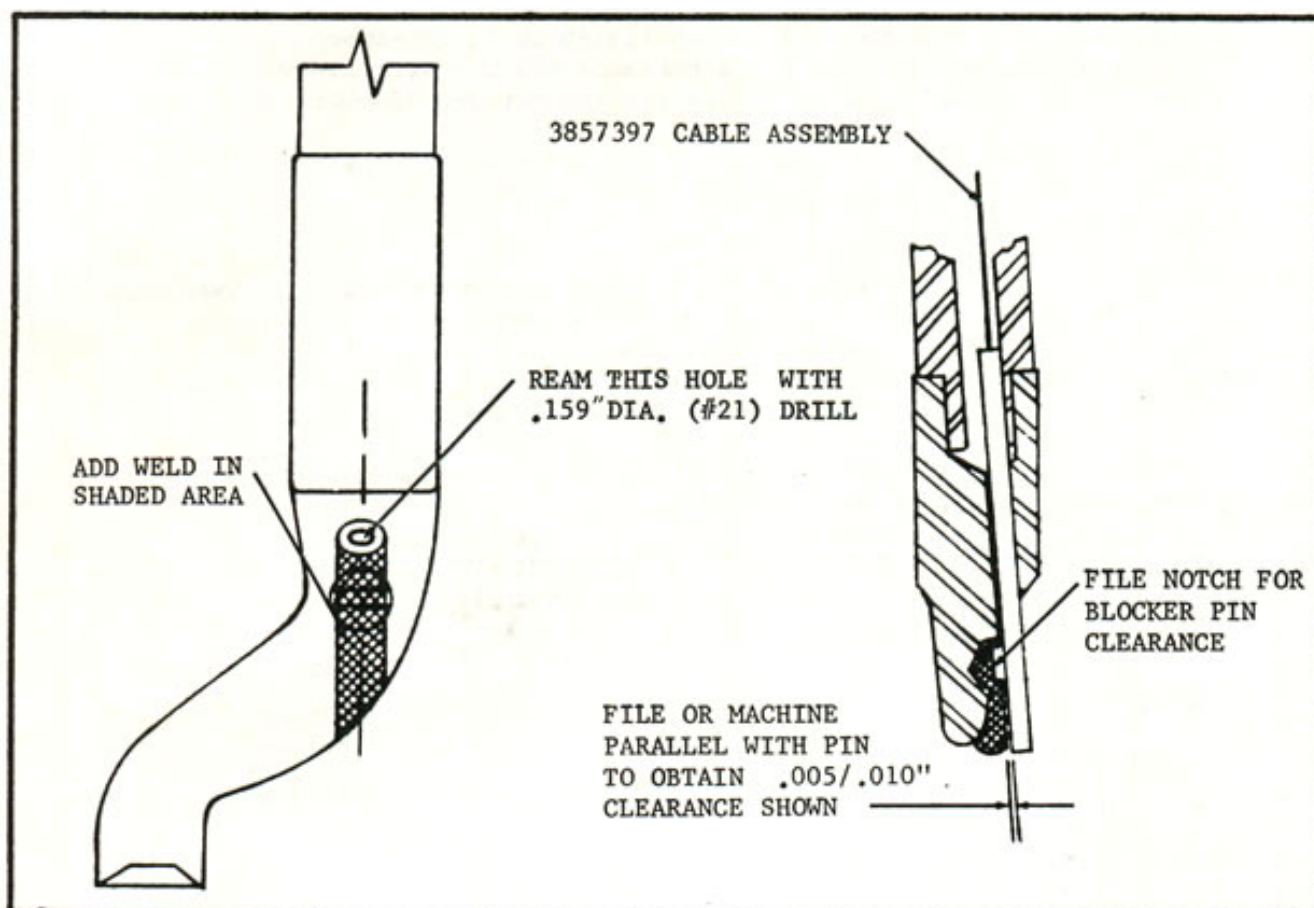
FIG. 4 - MODIFICATION OF SHIFT LEVER LOWER END

REVERSE INHIBITOR BINDS

2. Add a heavy weld or brass bead to the shift lever as shown by the shaded section of Figure 4.
3. File the bead flat and parallel to the reverse inhibitor pin with .005" to .010" clearance to the pin.
4. Remove and discard the pin and wire assembly from the "T" handle and enlarge the "T" handle hole to .082" with a 5/64" drill. Reassemble using the new pin and wire assembly, part number 3857397.

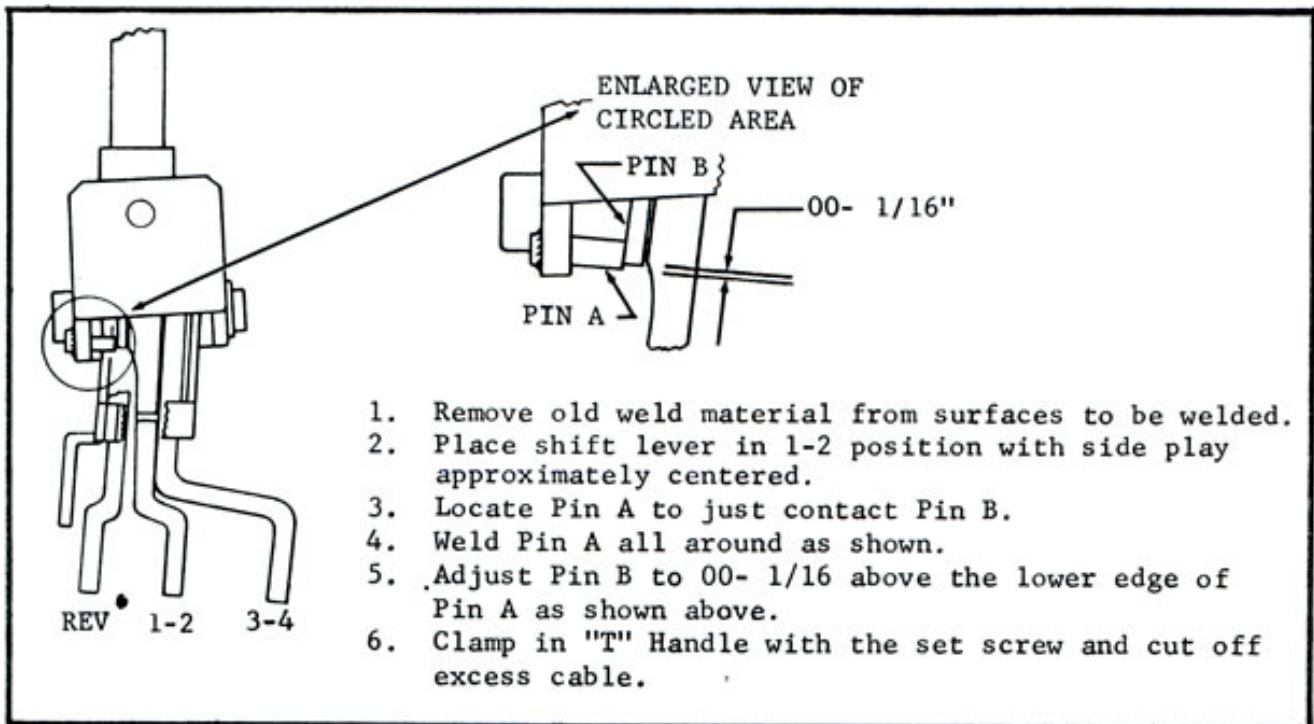
FIGURE 5 - REVERSE BLOCKER PIN LOCATING DETAILS

REVERSE BLOCKER PIN LOOSE OR MISSING

If the reverse blocker pin weld has broken, Figure 5 describes the proper locating dimensions for rewelding. If the original pin has been lost or damaged, a 1/4 inch by 5/8 inch hardened bolt, such as part no. 9409073, may

be used. The shift mechanism must be fully assembled before welding the pin so that the proper pin location may be achieved.
