1964 Corvette: Service Bulletin: 4-Speed Shift Lever Revision

Source: Chevrolet Technical Service Bulletin

Bulletin No: DR #691

Date: September 8, 1964

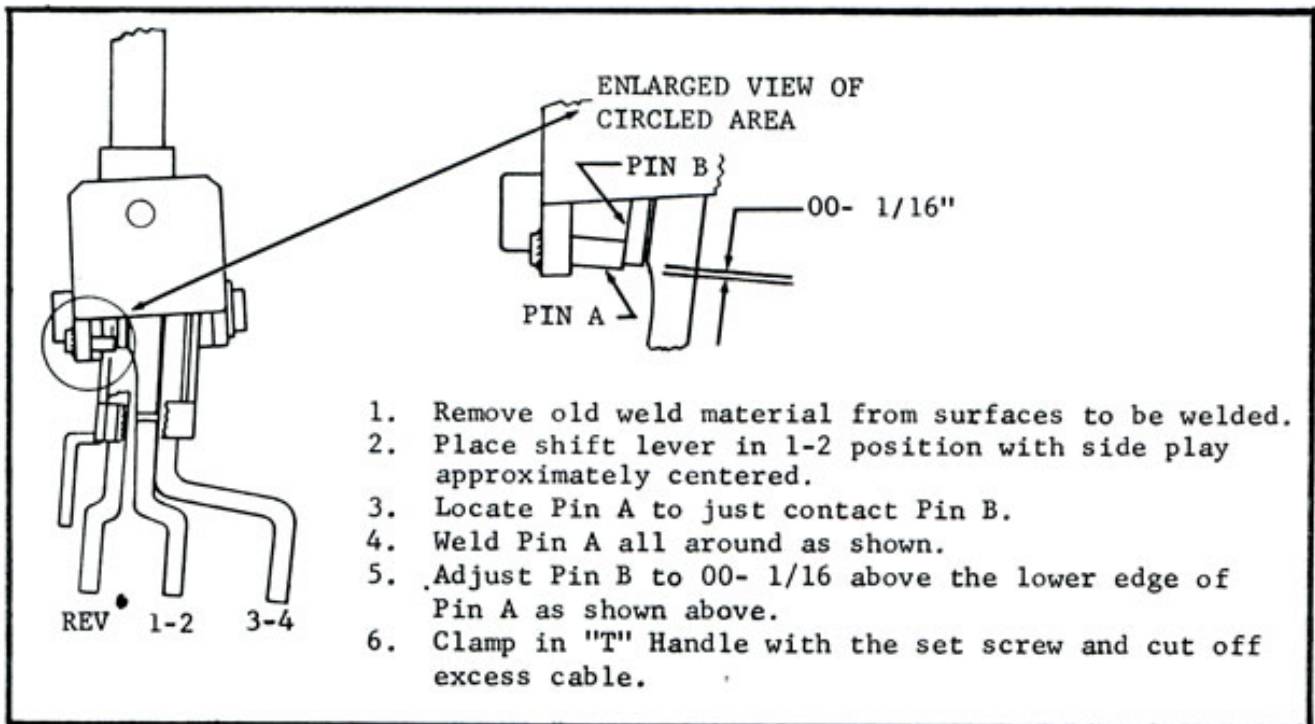
FIGURE 5 - REVERSE BLOCKER PIN LOCATING DETAILS

REVERSE BLOCKER PIN LOOSE OR MISSING

If the reverse blocker pin weld has broken, Figure 5 describes the proper locating dimensions for rewelding. If the original pin has been lost or damaged, a 1/4 inch by 5/8 inch hardened bolt, such as part no. 9409073, may

be used. The shift mechanism must be fully assembled before welding the pin so that the proper pin location may be achieved.
