1963 - 1967 Corvette: Service Bulletin: Fuel Gauge System Diagnosis

Subject: Fuel Gauge System Diagnosis

Source: Chevrolet Technical Service Bulletin

Bulletin Number: DR #752, Section VIII

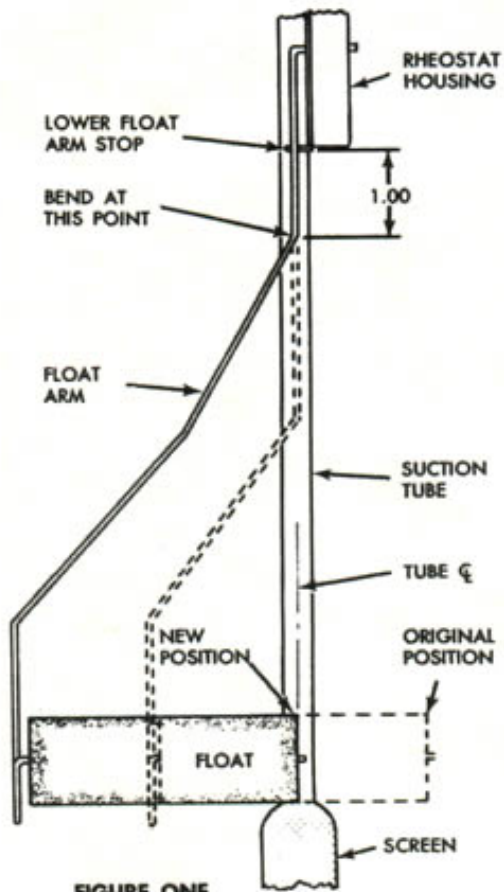
On the 1965 Chevrolet Station Wagon tank units, complaints of "never reads less than 1/4" or "tank rattle" may be caused by an interference between the tank unit float and the tank ribs due to an improper mounting flange angle. This problem has been corrected in production and identified by an orange paint mark at the sender mounting area.

CAUTION: In the above procedure, there is a possibility of breaking the solder joint where the suction tube passes through the mounting plate. If this occurs, or if a new tank sending unit is installed on tanks without the orange paint identification, the replacement sending unit should be reworked per Figure 1 (Page 6) prior to installation.

When the complaint of erratic or stuck gas gauge on station wagons is encountered, correction can be made by inserting a clean rod approximately 3/8 dia. and 3 ft. long through the filler hole and extending inboard of the suction tube, and bending the tube (not the float arm) outboard till the float is heard to hit the outboard side of the tank. The spring back of the tube, after this operation will approximately center the float in the tank and eliminate interference.

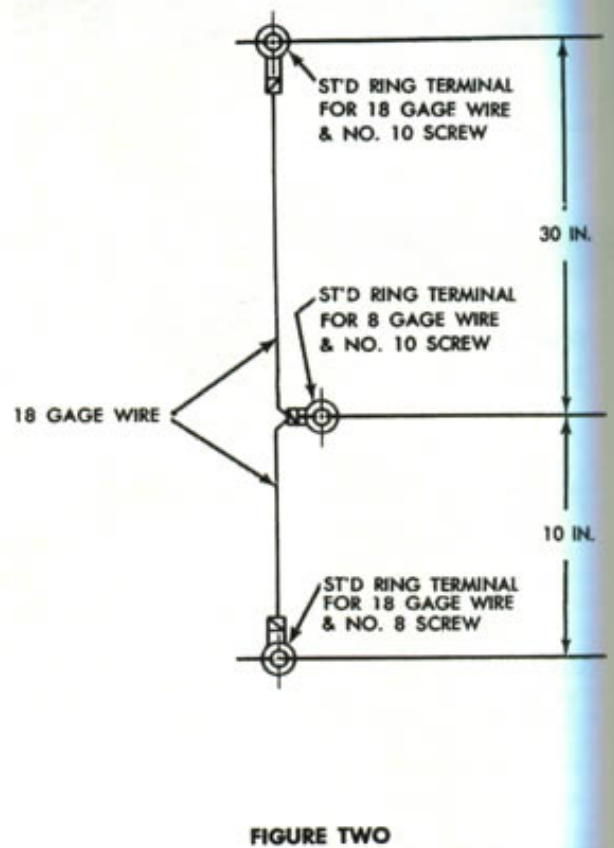
a) Dash unit ground - the 1965 Chevrolet uses two stud mounted clips to both ground and retain the instrument cluster. This circuit is sensitive to dimensional variation and may be tested with a jumper wire from each stud to the chassis.

If ground circuit correction is needed, make a ground wire assembly as shown in Figure 2, Page 6. Install as shown in Figure 3, Page 6.
