1963 - 1967 Corvette: Service Bulletin: Fuel Gauge System Diagnosis

Subject: Fuel Gauge System Diagnosis

Model and Year: 1967 Corvette

Bulletin Number: DR #752, Section VIII

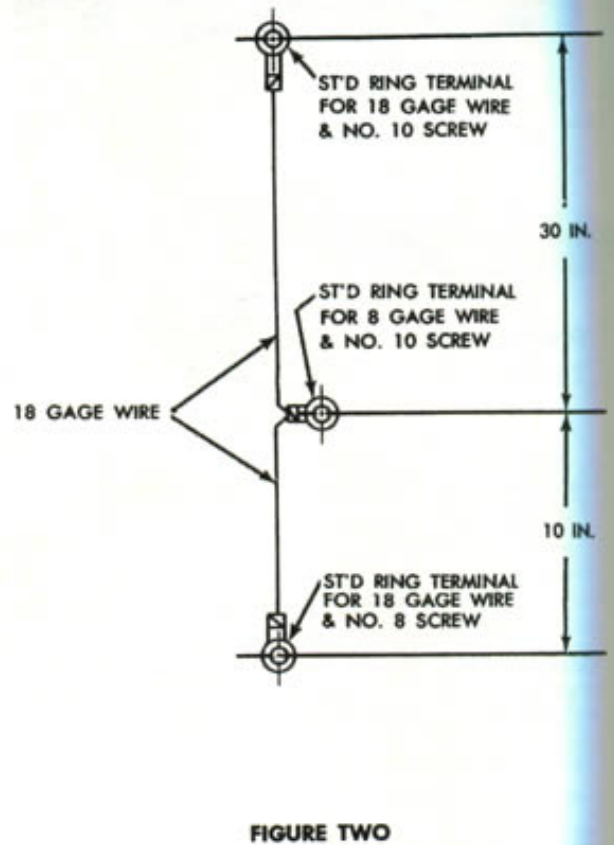
a) Dash unit ground - the 1965 Chevrolet uses two stud mounted clips to both ground and retain the instrument cluster. This circuit is sensitive to dimensional variation and may be tested with a jumper wire from each stud to the chassis.

If ground circuit correction is needed, make a ground wire assembly as shown in Figure 2, Page 6. Install as shown in Figure 3, Page 6.
