1984 Corvette: Service Bulletin: Engine Stops Running When Starting with Air Conditioning "On"

Subject: Engine Stops Running When Starting with Air Conditioning "On"
Model and Year: 1984 Corvette with Automatic Transmissions
Source: Chevrolet Dealer Service Bulletin
Bulletin No: 84-240
Section: 8B (XII)
Date: Feb. 1985

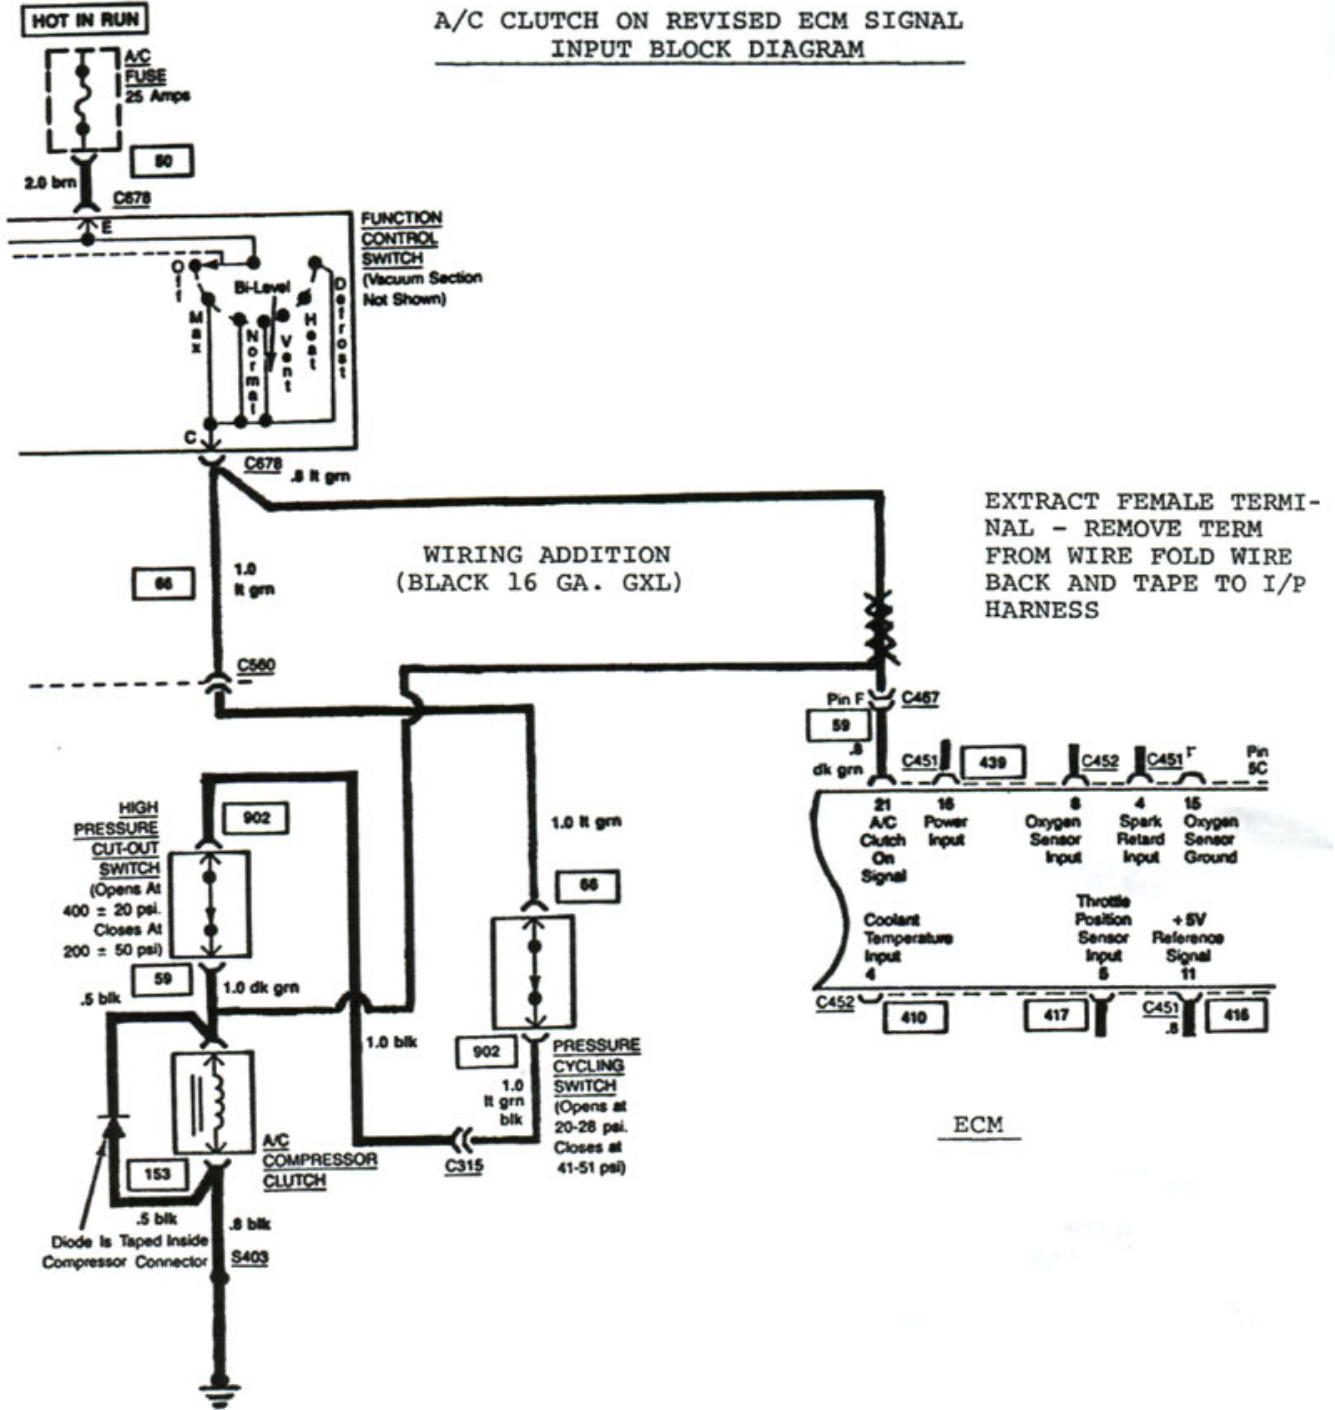
**A/C CLUTCH ON REVISED ECM SIGNAL
INPUT BLOCK DIAGRAM**

This revision requires installing a 16 Ga. wire into the A/C discrete circuit at connector C-467, Pin F of the I/P to ECM harness, routing the wire through the bulk head connector and splicing into the A/C circuit of the engine, between the pressure cycling switch and the compressor clutch (see block diagram).
